Cape Shoalwater and Washaway Beach

May 18, 2012

Cape Shoalwater is on the Washington Coast south of Ocean Shores. This area is home to the communities of North Cove and Tokeland. This exercise looks at the regional setting and investigates both long- and short-term changes that have taken place (Figure 1). We will use topographic maps, aerial photos and nautical charts for this investigation.

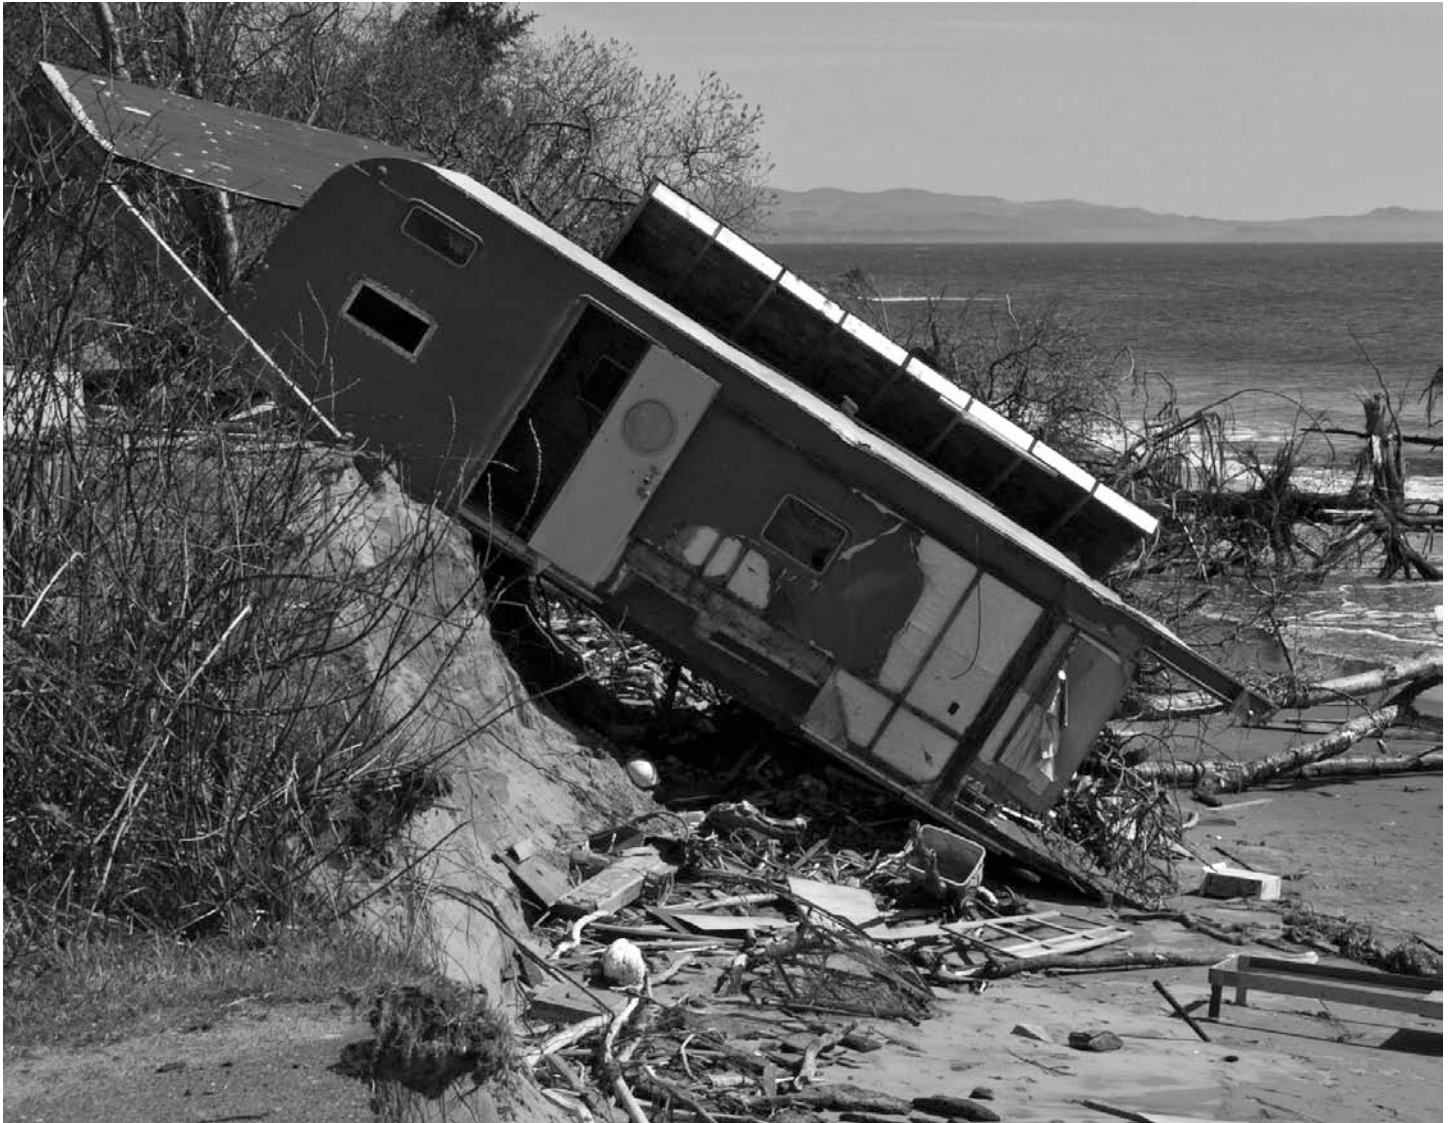
Figure 1. Trailer that has fallen off the cliff edge as a result of being undercut, at North Cove. Photograph taken April, 2012.

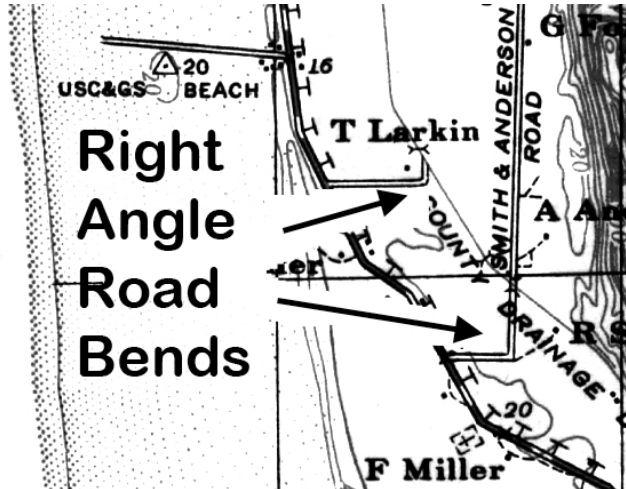
Figure 5, right angle bends for location purposes on topographic maps (1938 base map).

On the 1938 map, note the right angle bend in Smith and Anderson Road, and the right angle bend in the road by the name T Larken (for reference see the small map below). Also note the intersection where Larken Road joins the main north-south highway. Measure directly south from the road bend for each case discussed below.

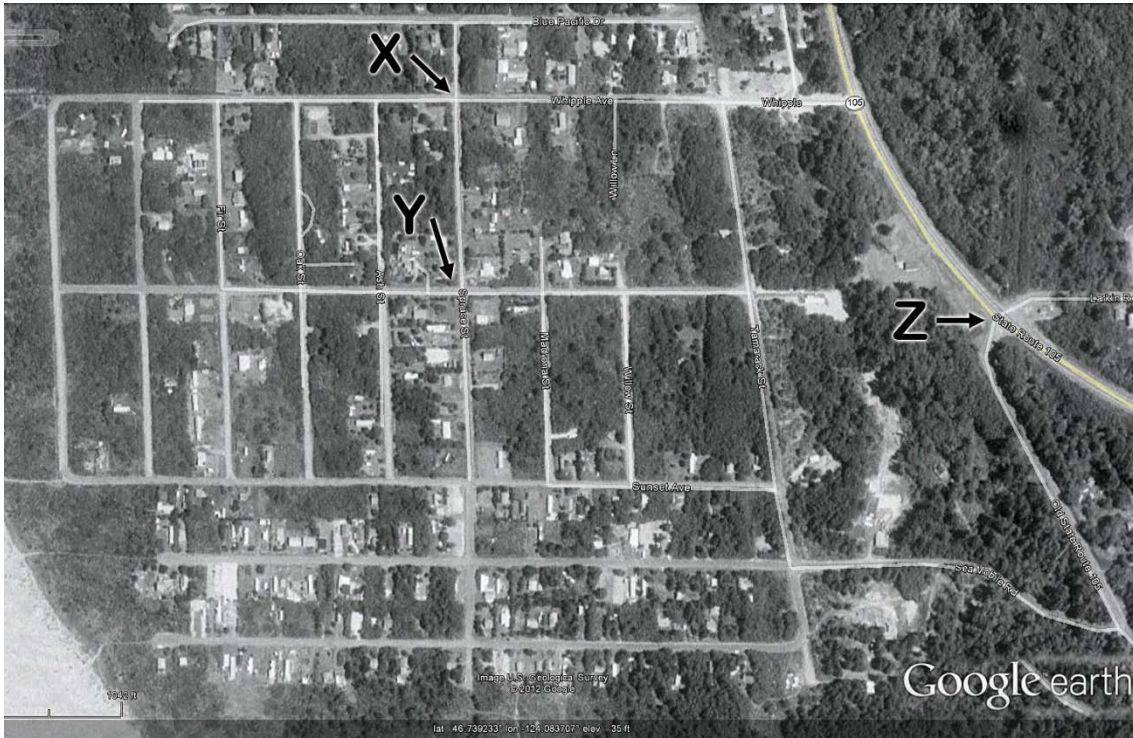
Figure 11. Location map of North Cove. North is at the top of the map. “X” is at the intersection of Whipple (the E-W road) and Spruce (the N-S road).

The image below (Figure 11) is a location map that you can use with the rest of the images. Point X is the intersection of Spruce and Whipple, and is the point from which erosion measuring should be based. The intersections at points Y and Z are useful fixed points for reference.

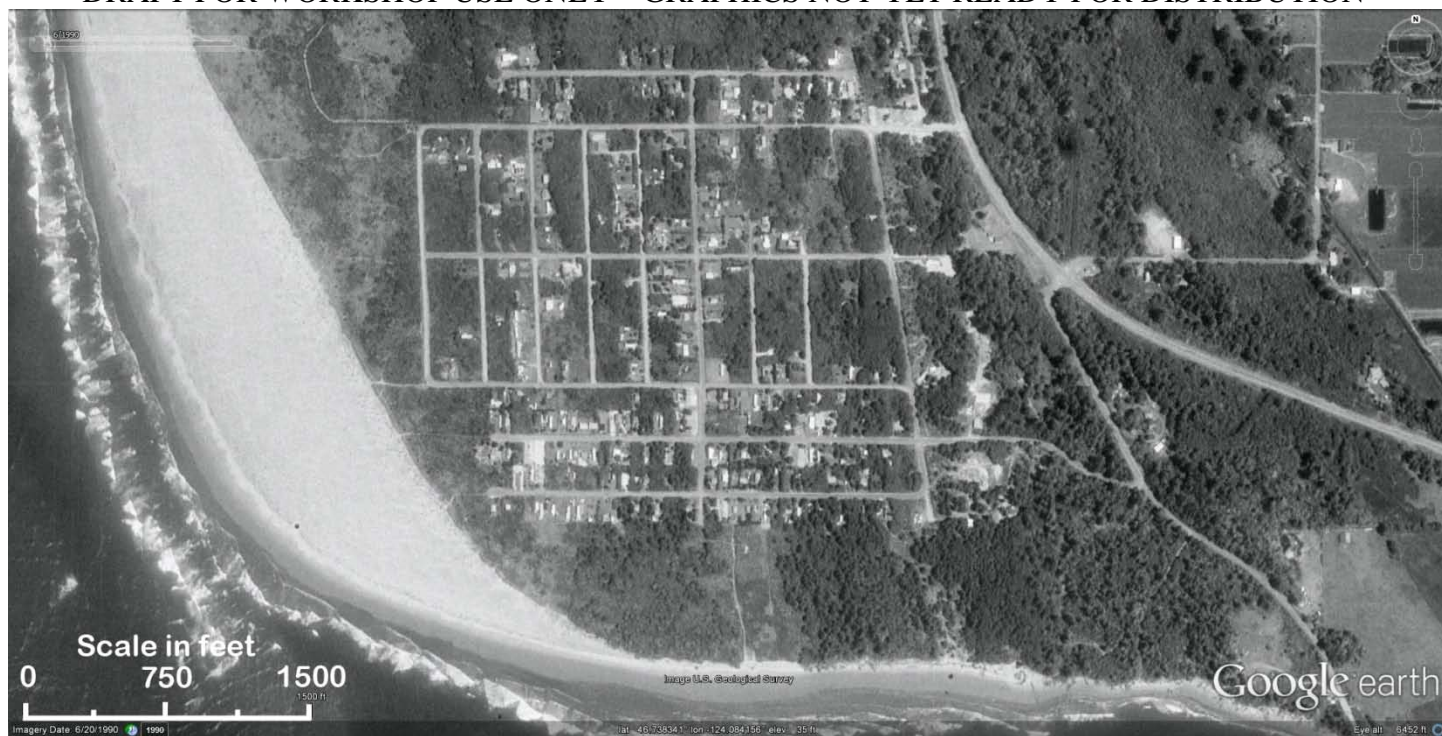
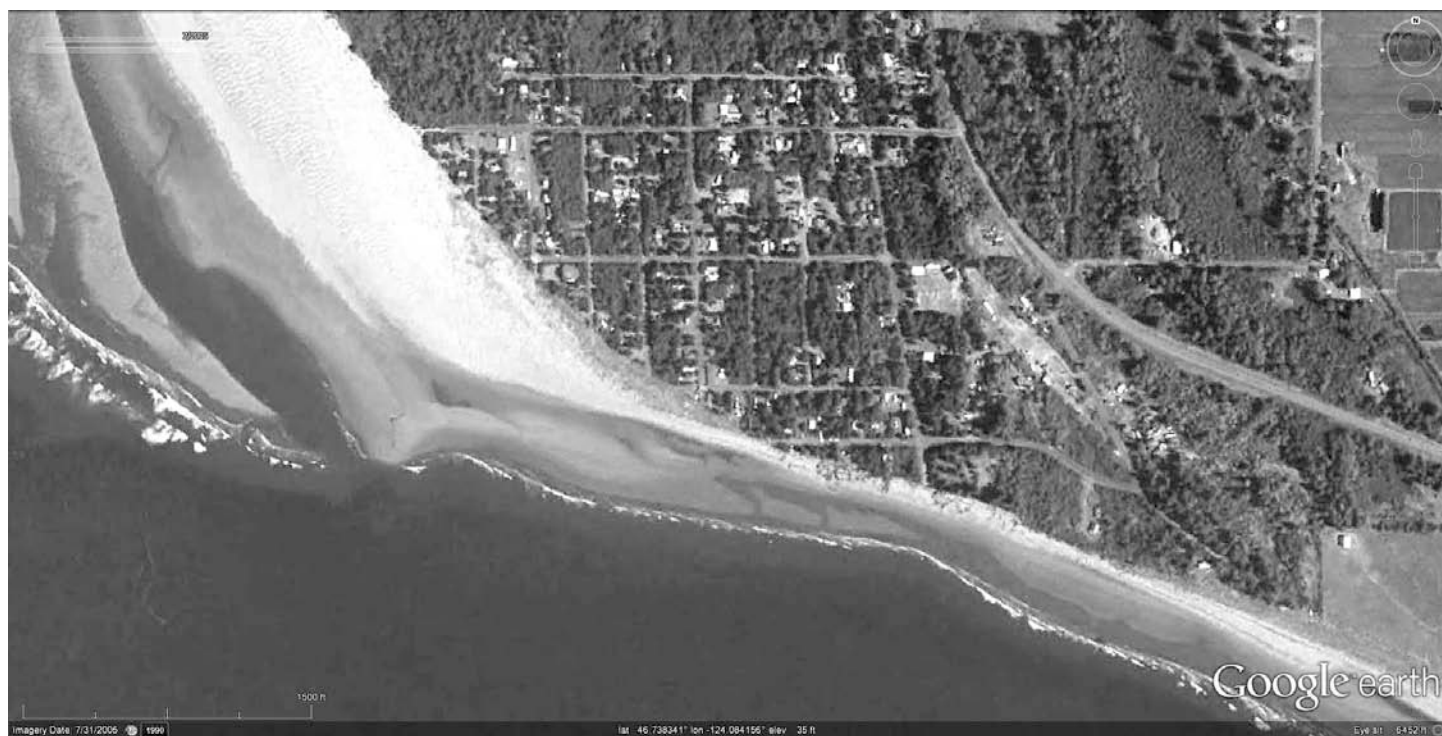
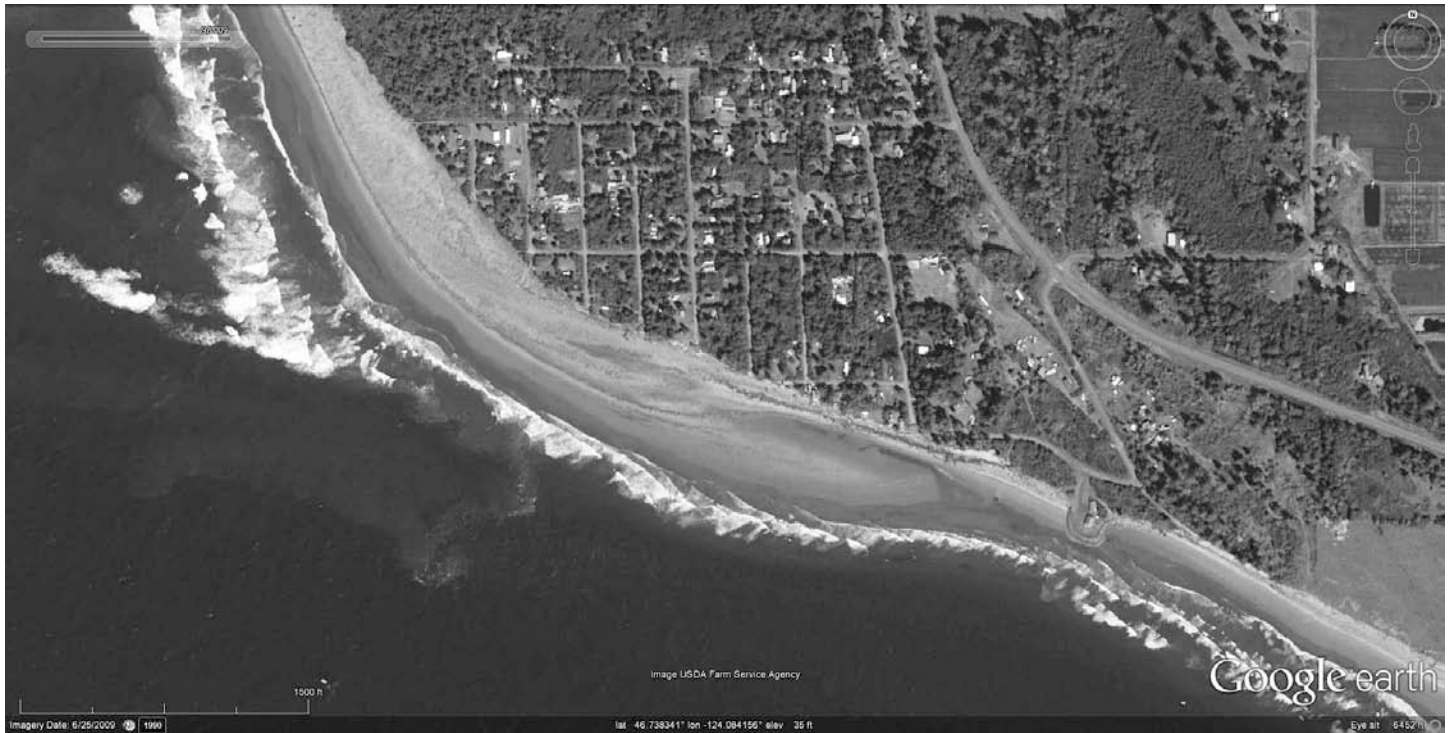
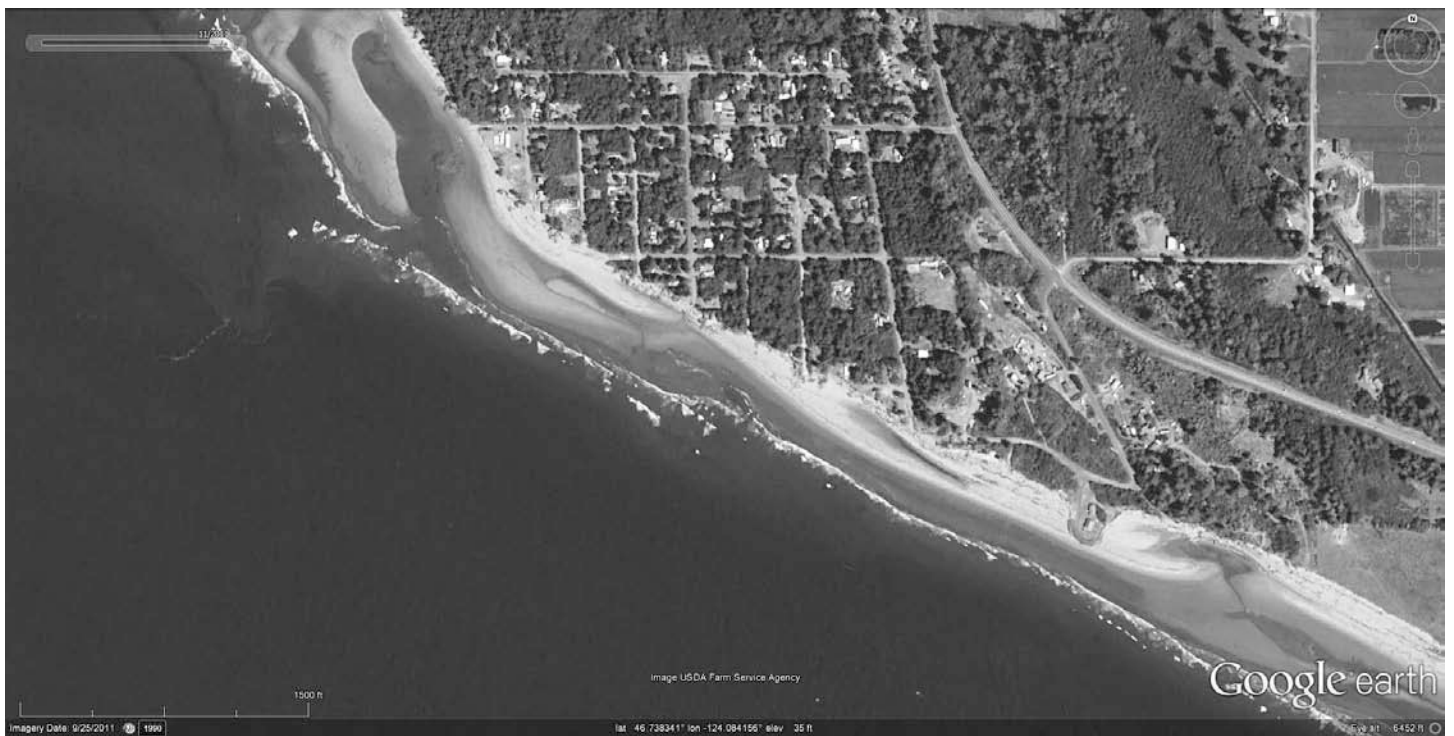
Figure 12a, 1990

Figure 12b, 2005

Figure 12c, 2009

Figure 12d, 2011

20. Use data from the four figures below (Figures 12a-d) to complete the table below the images.

Note that all the images are the same scale, so the scale on the 1990 image can be applied to the other images. North is at the top of all the images.

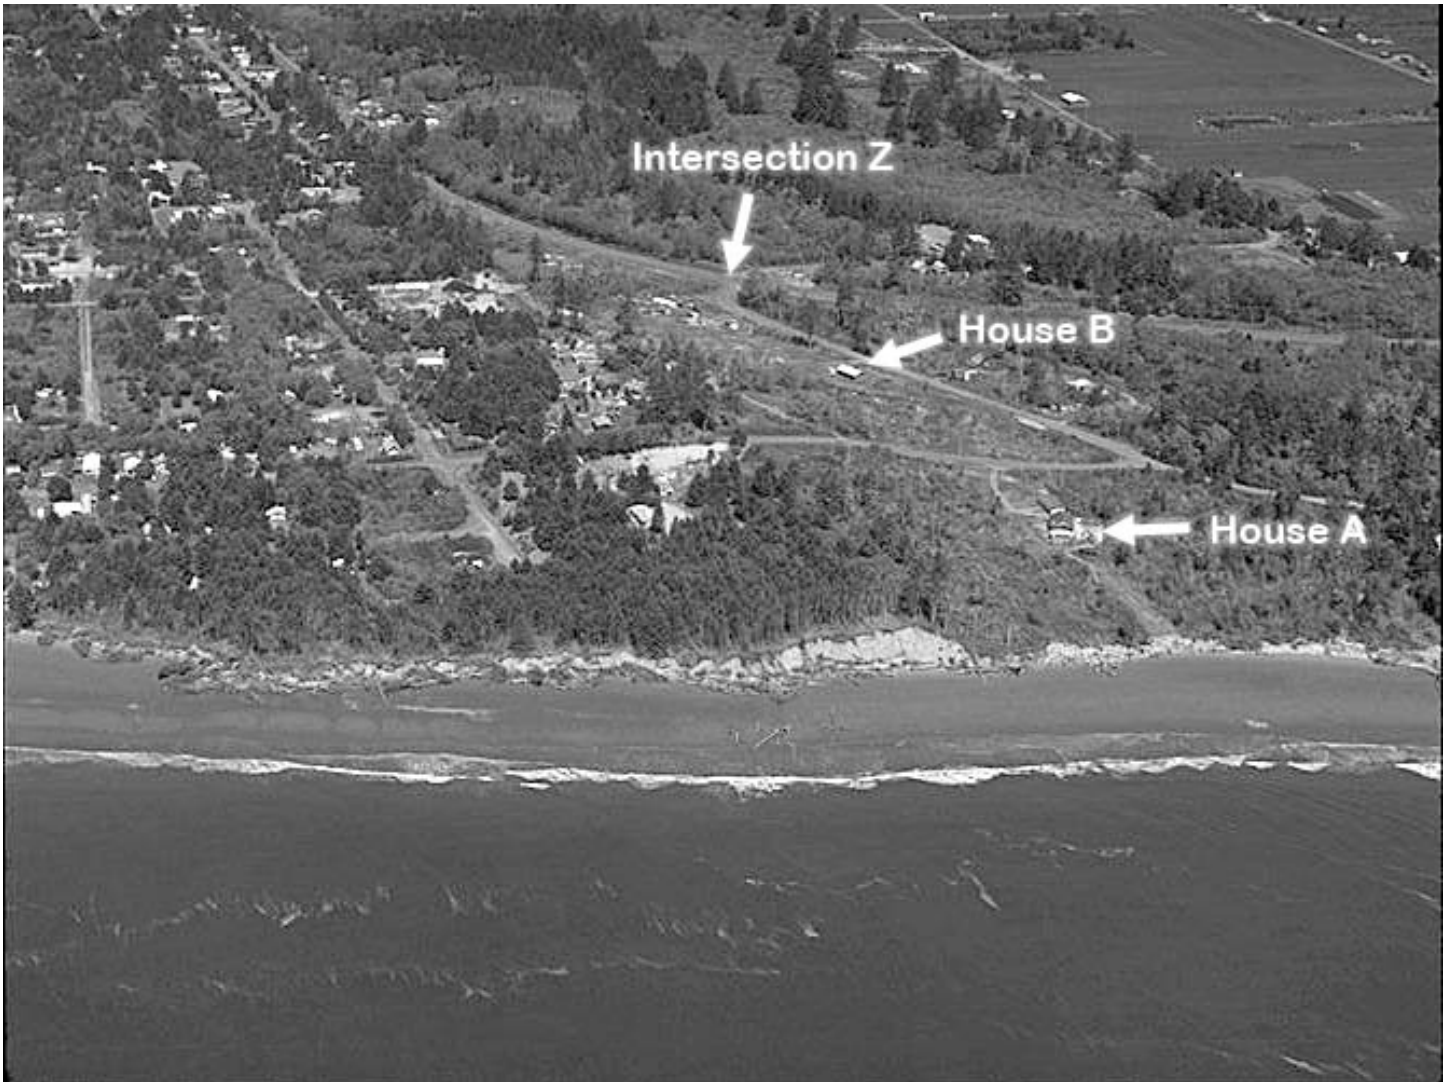
Figure 13. Oblique aerial photograph from 1997.

24. The oblique aerial photo below (Figure 13) has two houses indicated on it. Intersection Z is shown for comparison with the earlier images. The image is from <http://apps.ecy.wa.gov/shorephotos/scripts/bigphoto.asp?id=PAC0015>, downloaded May 18, 2012.

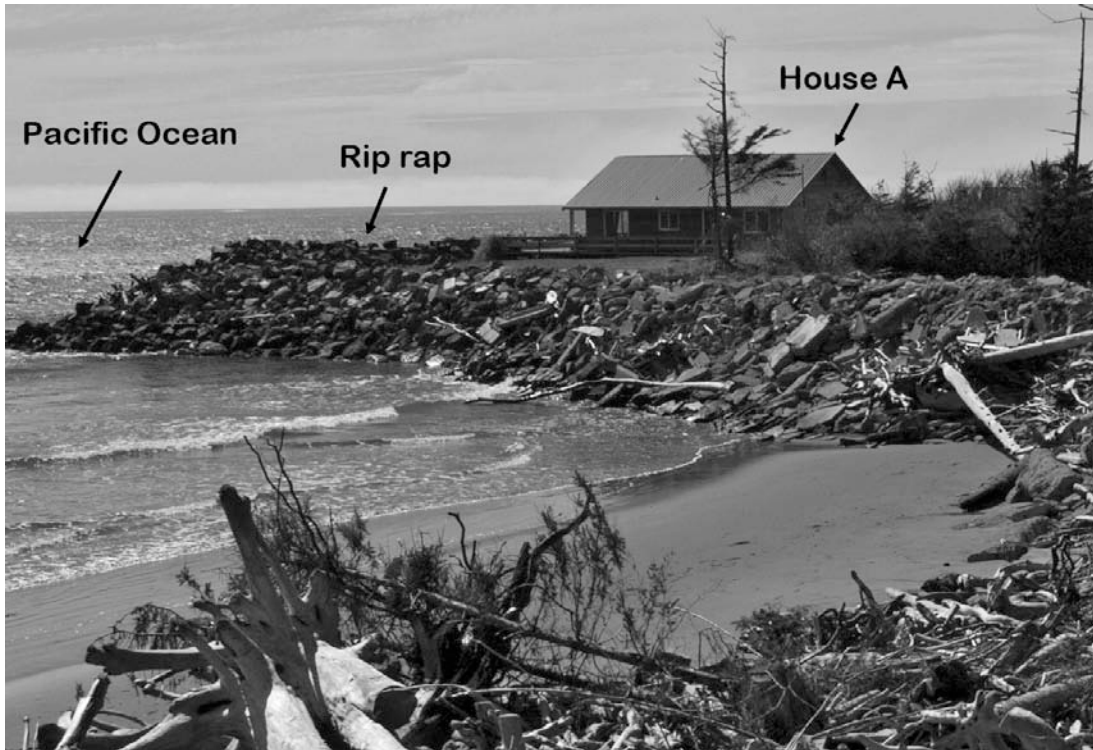
Figure 14. House A, looking west southwest from shore, May 2012.

b. House A has been protected by large rocks, known as rip-rap (see Figure 14, photograph of house A from May 2012). These rocks are now serving as a property-specific seawall to protect the house. On a larger scale, however, they might be serving as either a wide groin or perhaps a small rocky headland. How might the protection of this property be influencing erosion or deposition at adjacent properties?
