Physical Properties and Characteristics of Sediments in the East Transect at Dingley Island

Callie Gates and Betsy Gott

Bowdoin College, in conjunction with the New Meadows River Watershed Project (NMRWP)

December 10, 2003

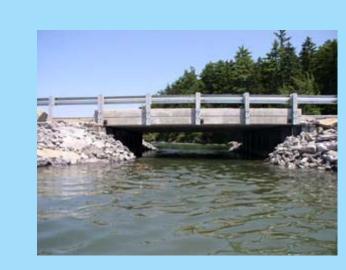
Figure 2: The depth of the layer of oxygenated mud increased at

sites ND-SA. The greatest increase in depth was at SA, directly

south of the bridge.

Decreased sediment depth and increased RPD shows that the oxygenated layer of mud is taking up a greater percentage of the total sediments in the East transect.

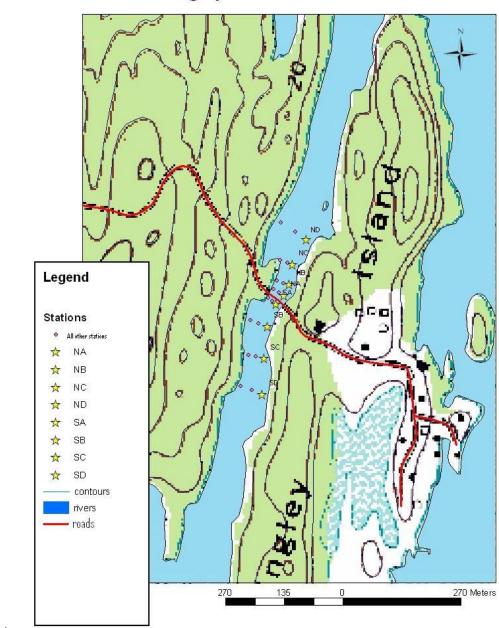
Figure 1: Map of East transect sample sites.

Dingley Island: East Transect

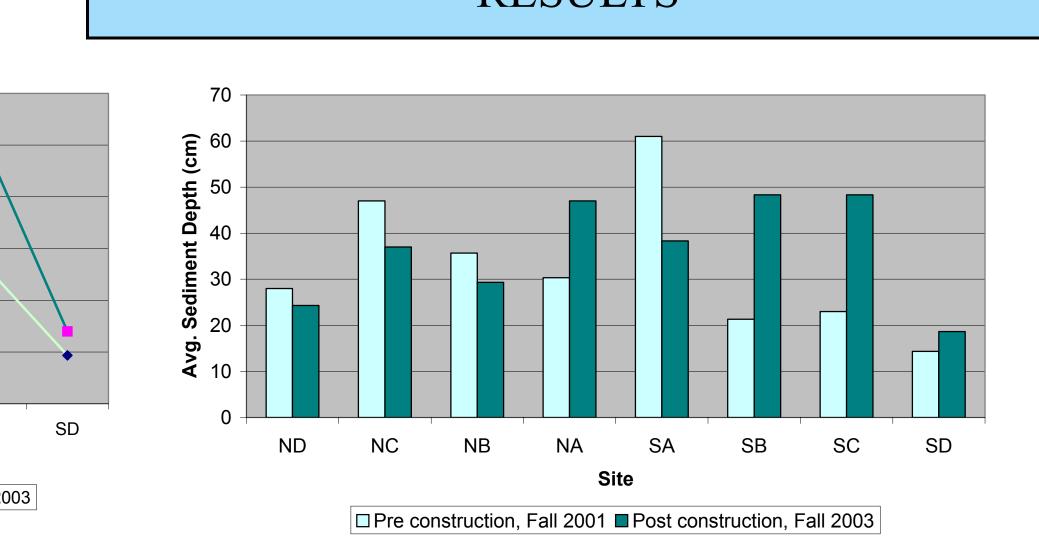
Figure 3: Overall, sediment depth decreased post-construction. The north side showed less change in sediment depth than the south side.

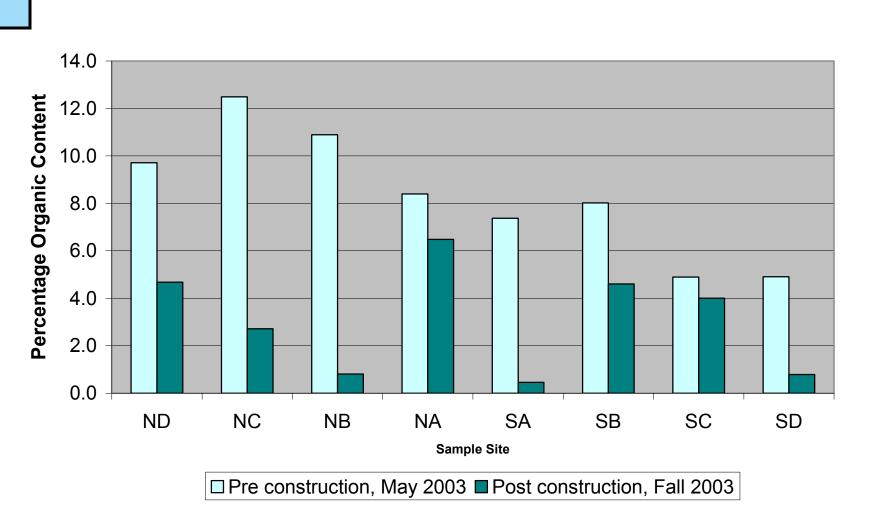
Figure 4: The percentage of organic carbon content decreased at every site along the transect, especially at SA.

- An increase in the oxygenated layer makes the mud more suitable for clam populations, which require oxygen-rich sediments.
- Decreased organic content also indicates that the mud is becoming healthier for clams; fewer microorganisms require less oxygen, leaving more oxygen available for clams.

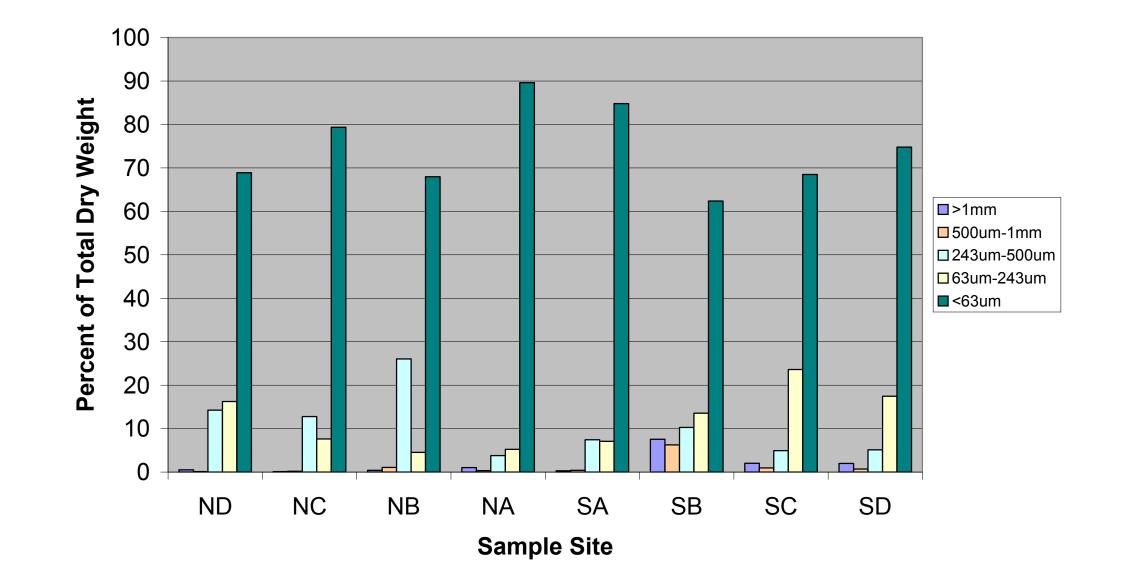
Figure 5: Post-construction: The vast majority of sediments are in the smallest grain size category, <63um. Very few sediments of the largest size were found, and when compared to Figure 5, a rise in sediments size 243um-500um from pre— to post-construction is apparent.

- Though the majority of sediments are still in the finest grain size category, post-construction data show an increase in medium-sized sediment grains. This indicates that the mud may be becoming more porous, and thus more oxygenated. This is in accordance with our RPD data.

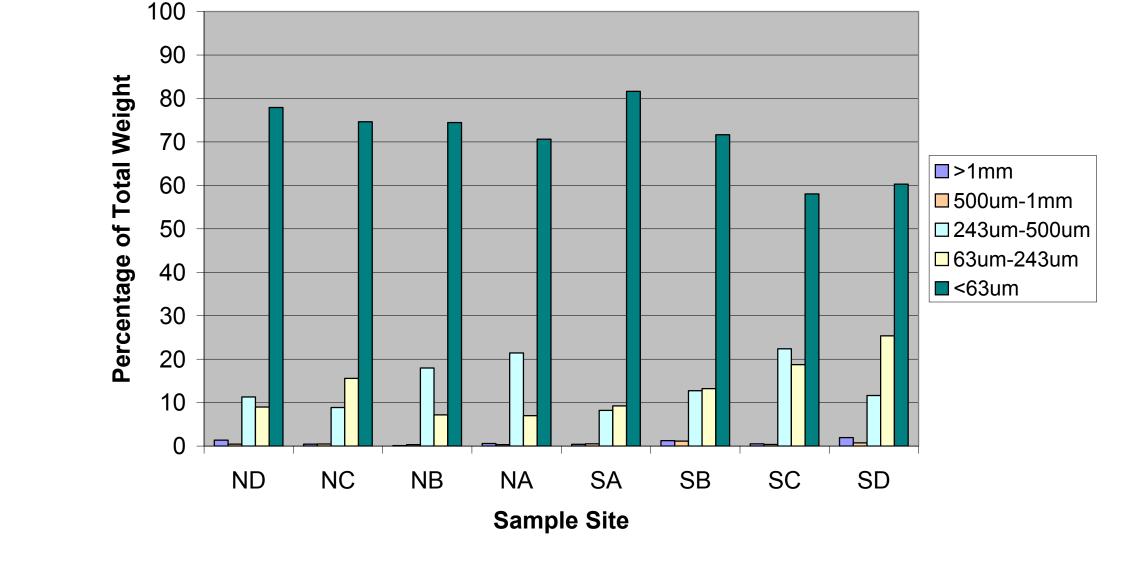
Figure 6: Pre-construction: As in Figure 5, the vast majority of the sediments are of the smallest grain size category of <63um.
