Image Sequence....

A River on the Move...

Notes/Thoughts/Quantifying

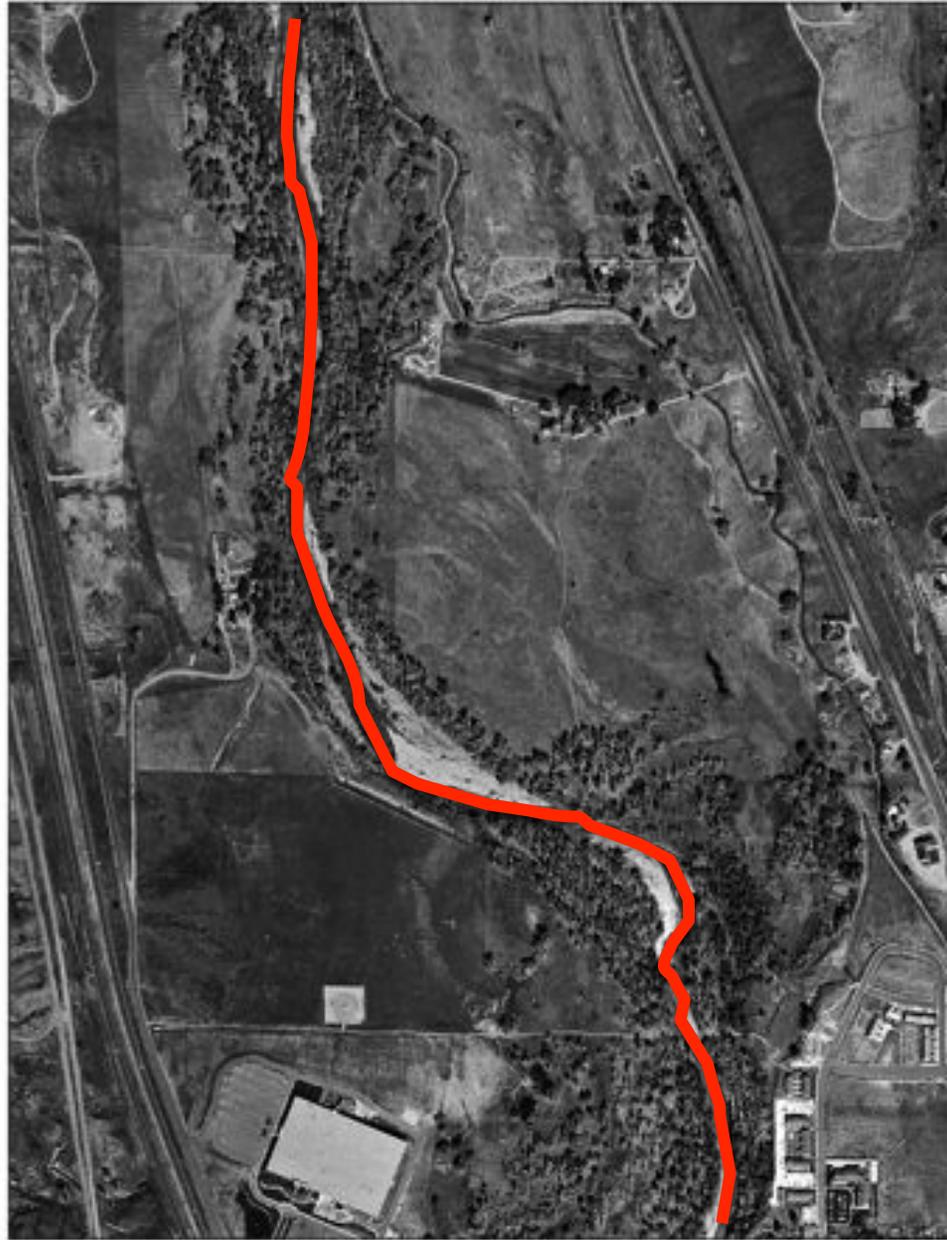
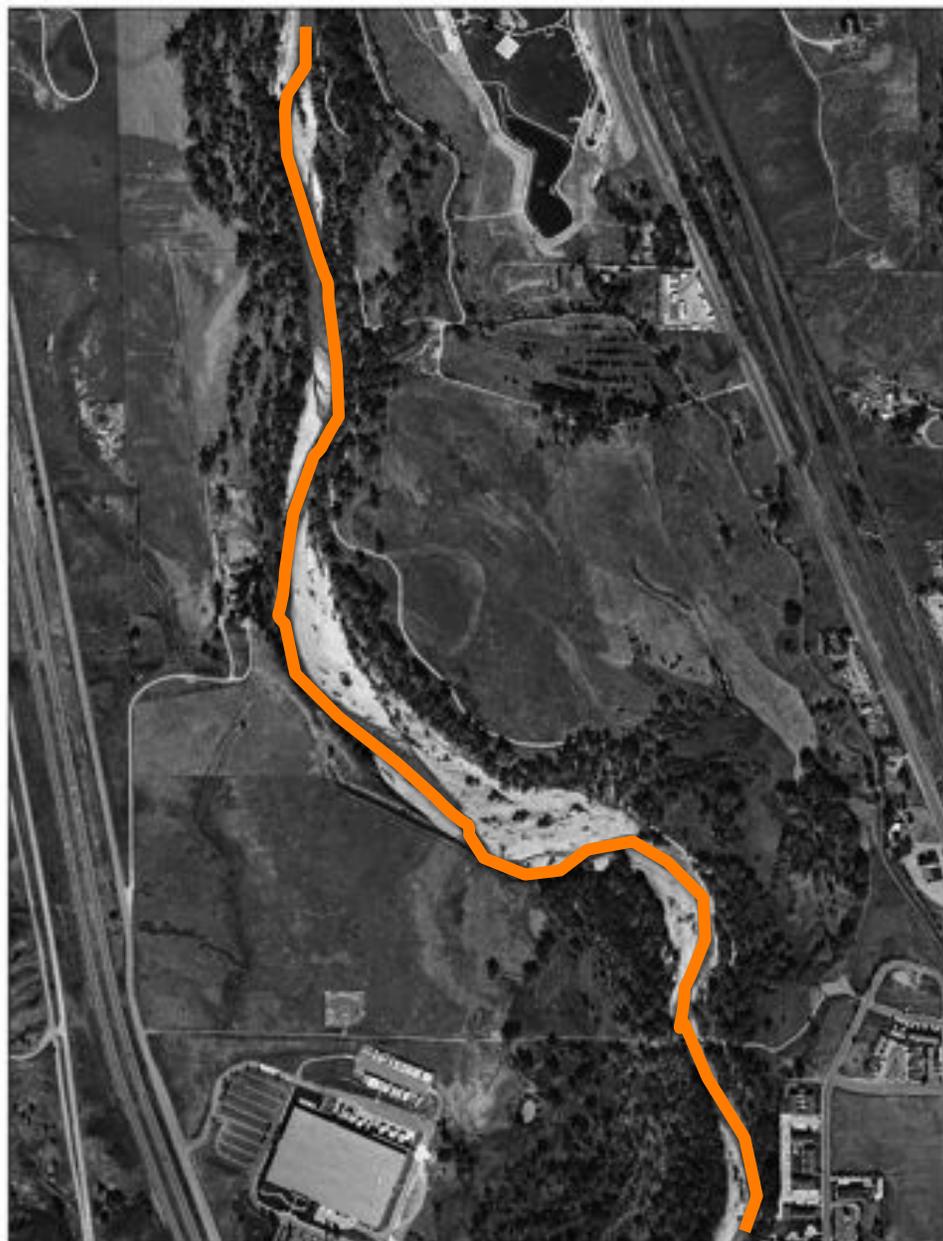
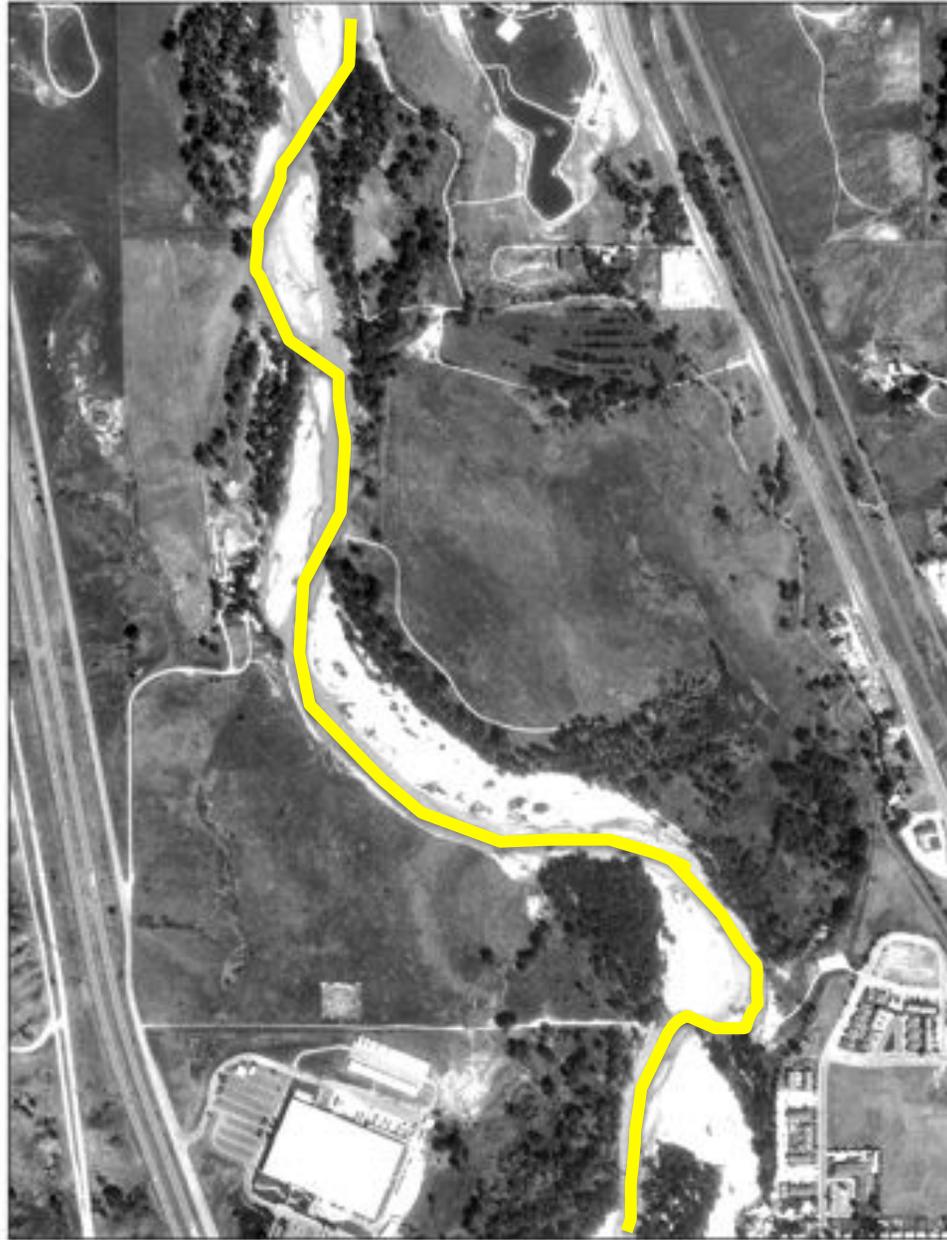
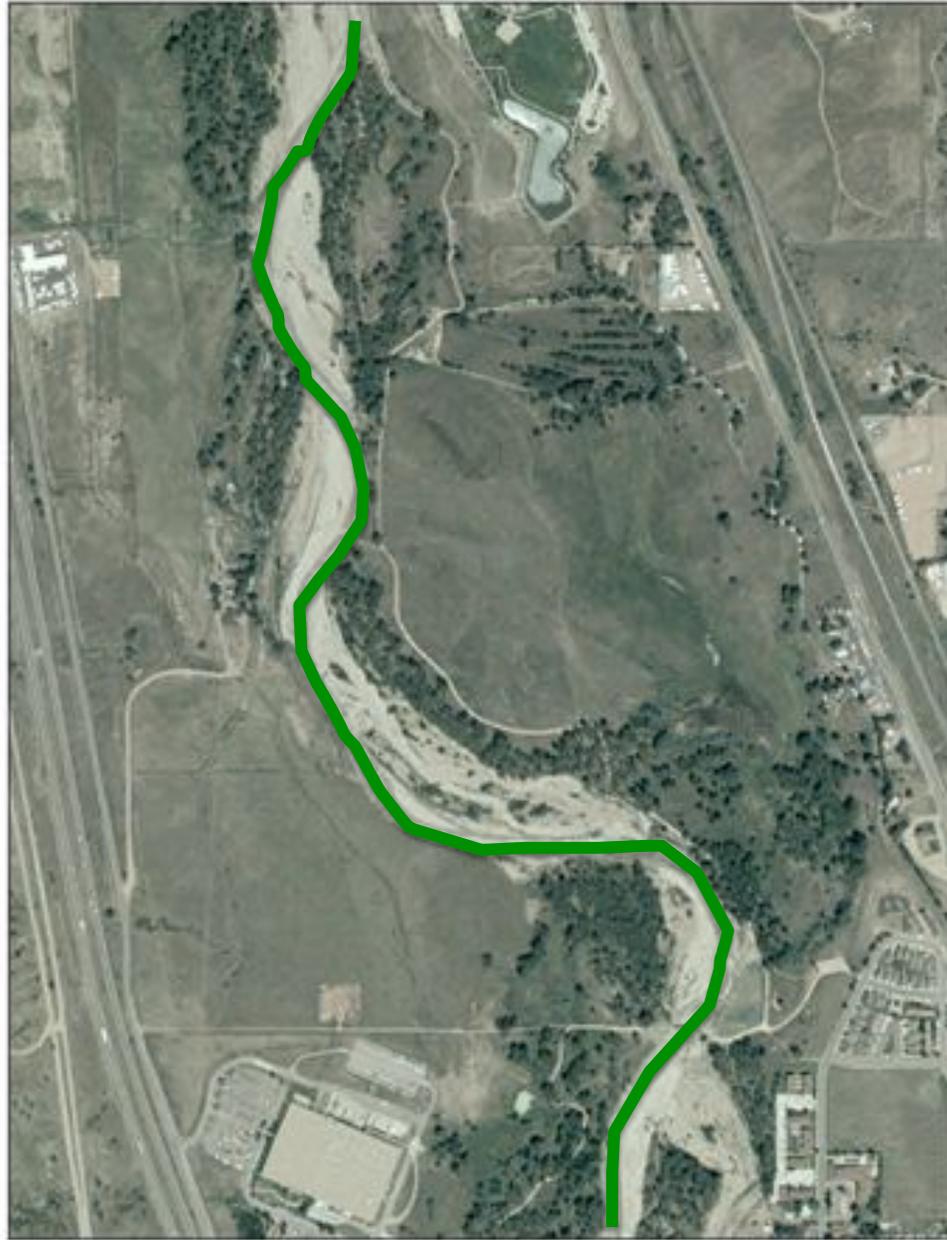
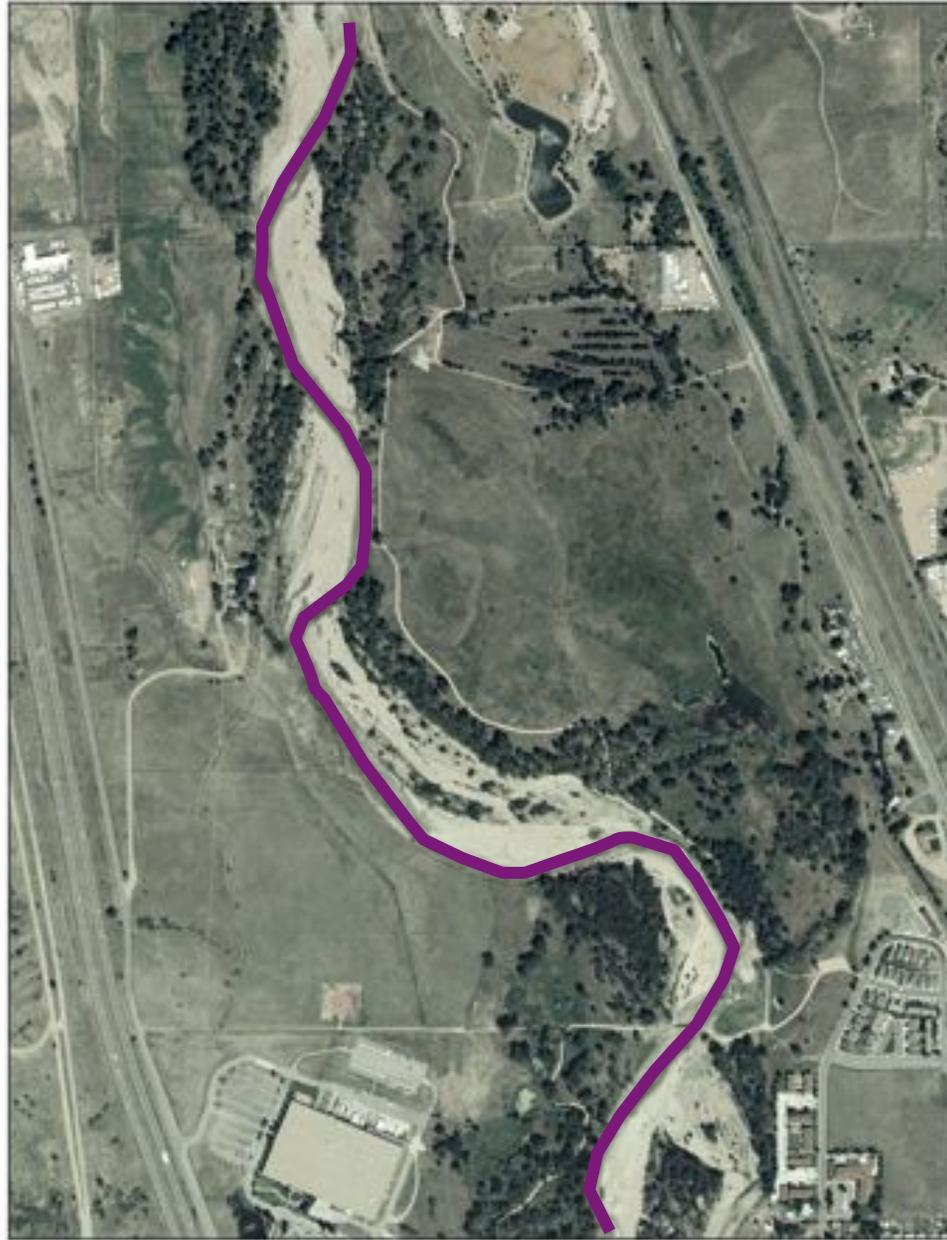
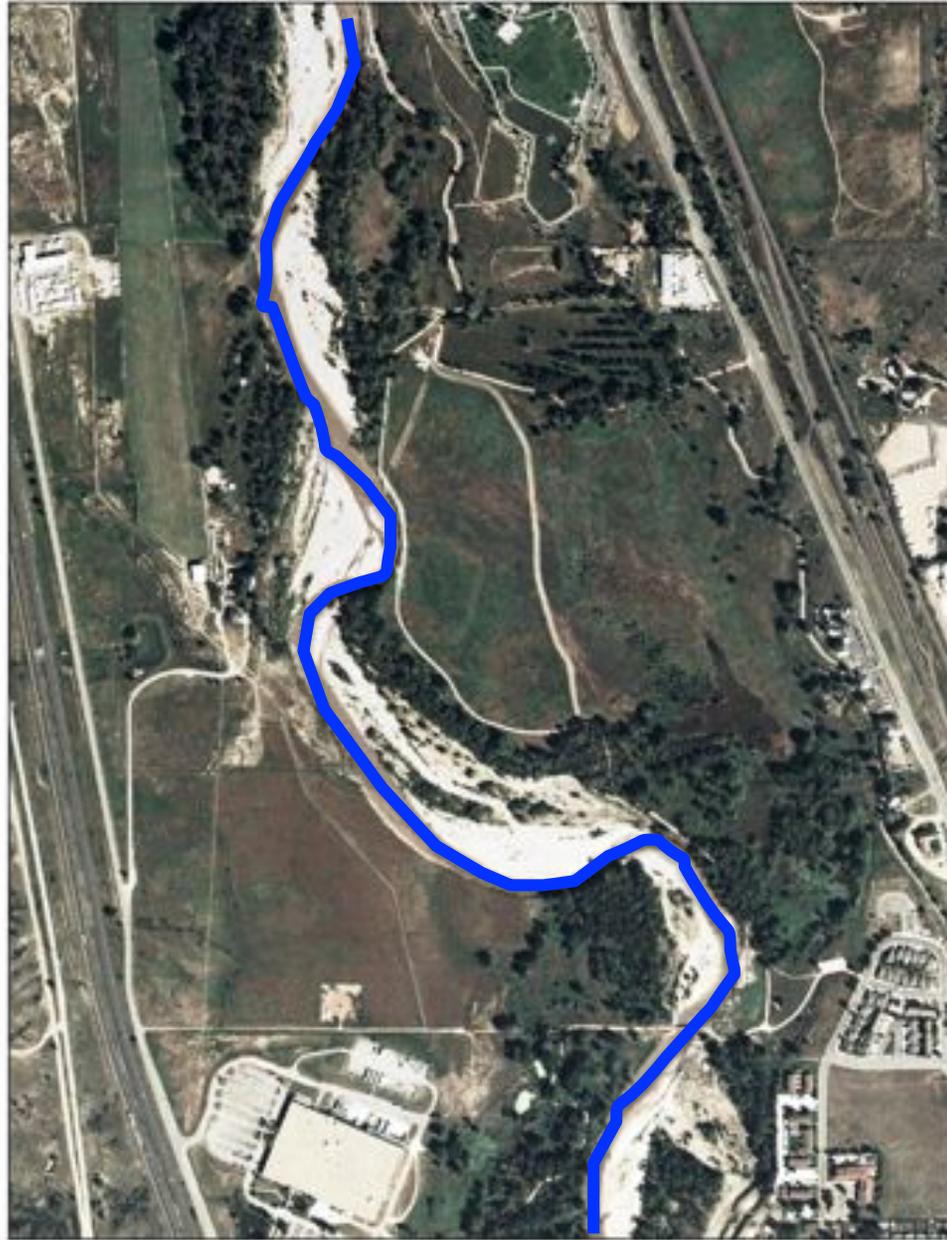
Image Sequence...with River traces...

Length Increase – Sinuosity Increase – SLOPE decrease!

Cut-bank migration and point bar growth...certain places appear to have much faster rates of movement than others...

Avulsion in the southern part of the focus area!

Role of big floods (1995, 1999)...taking out trees, bank cohesion...river banks were more stable, trees were preventing cut bank erosion, once gone (big floods), cut-bank erosion takes off...

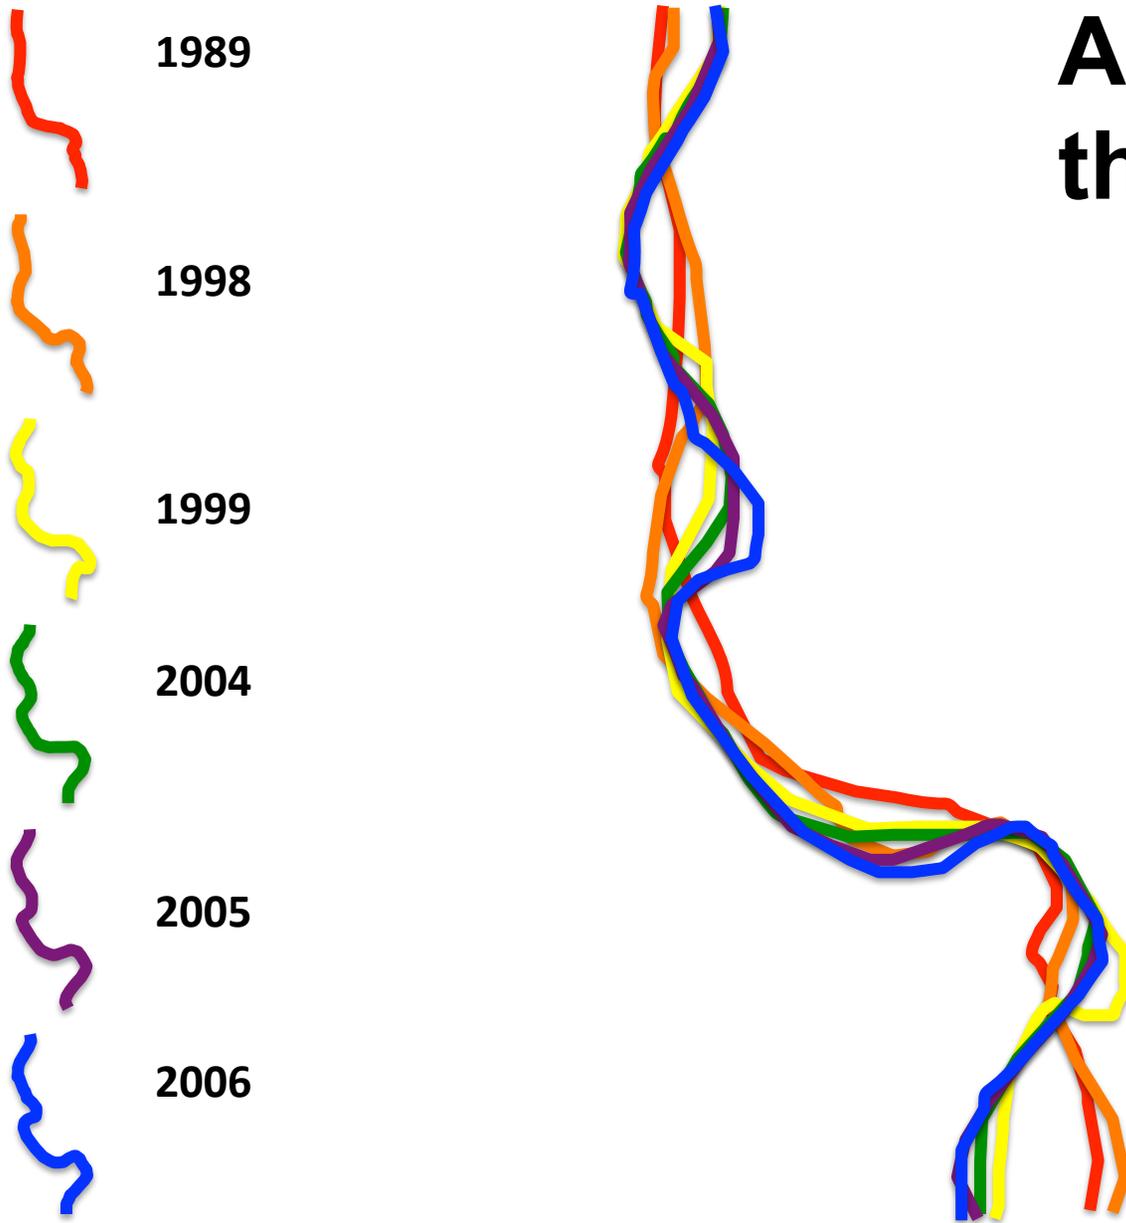
- some banks stabilized by humans (boulders/structures in place)

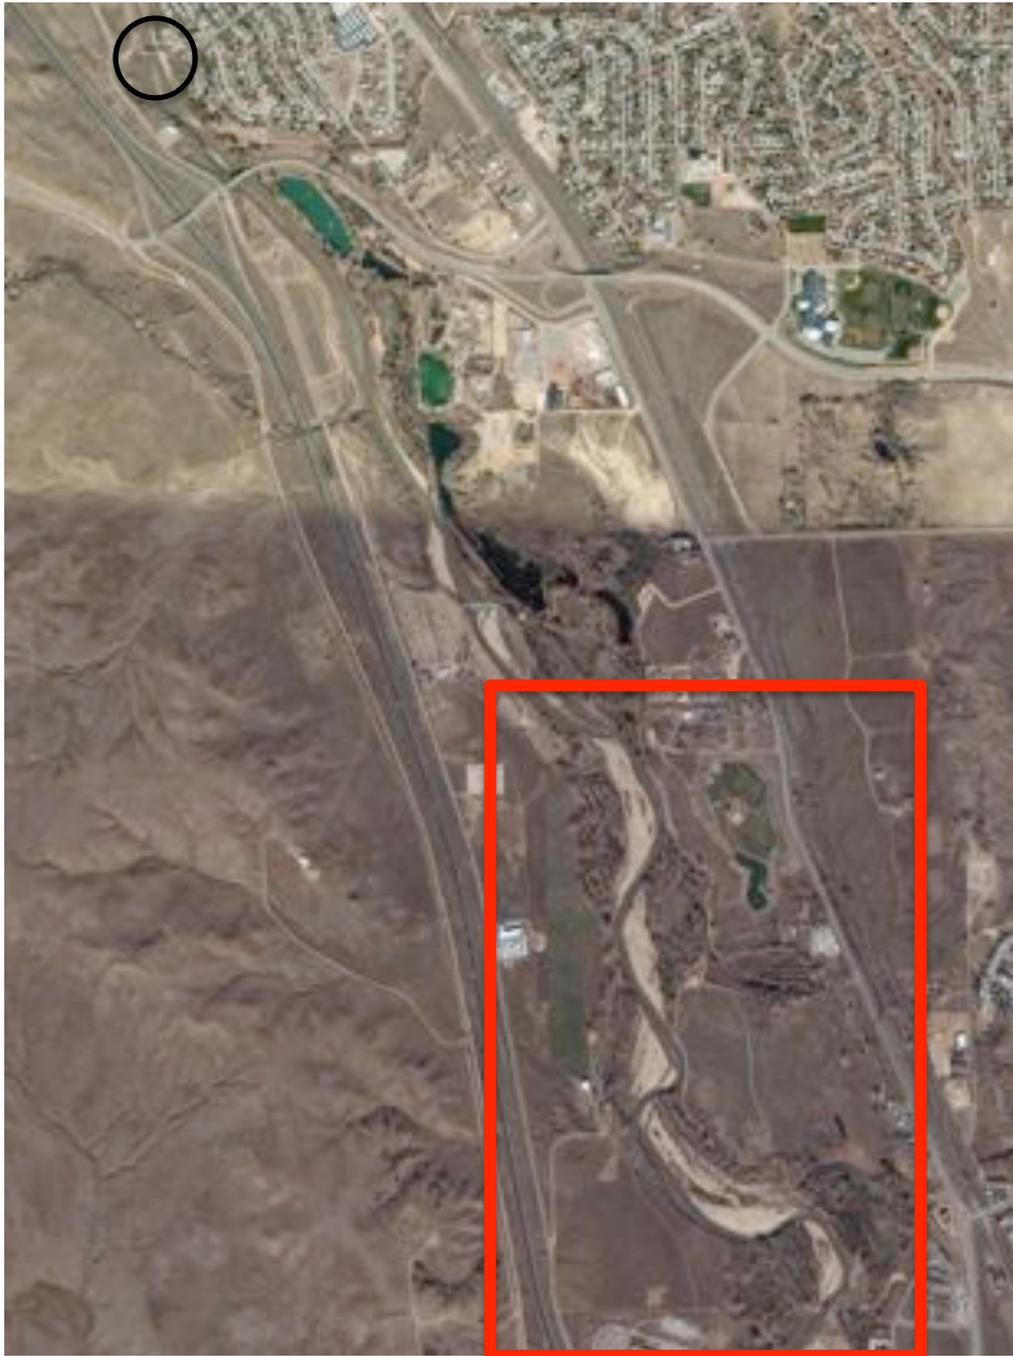
USGS Gage ~5 km upstream of our field site....

Downstream of major urban area...
Colorado Springs!

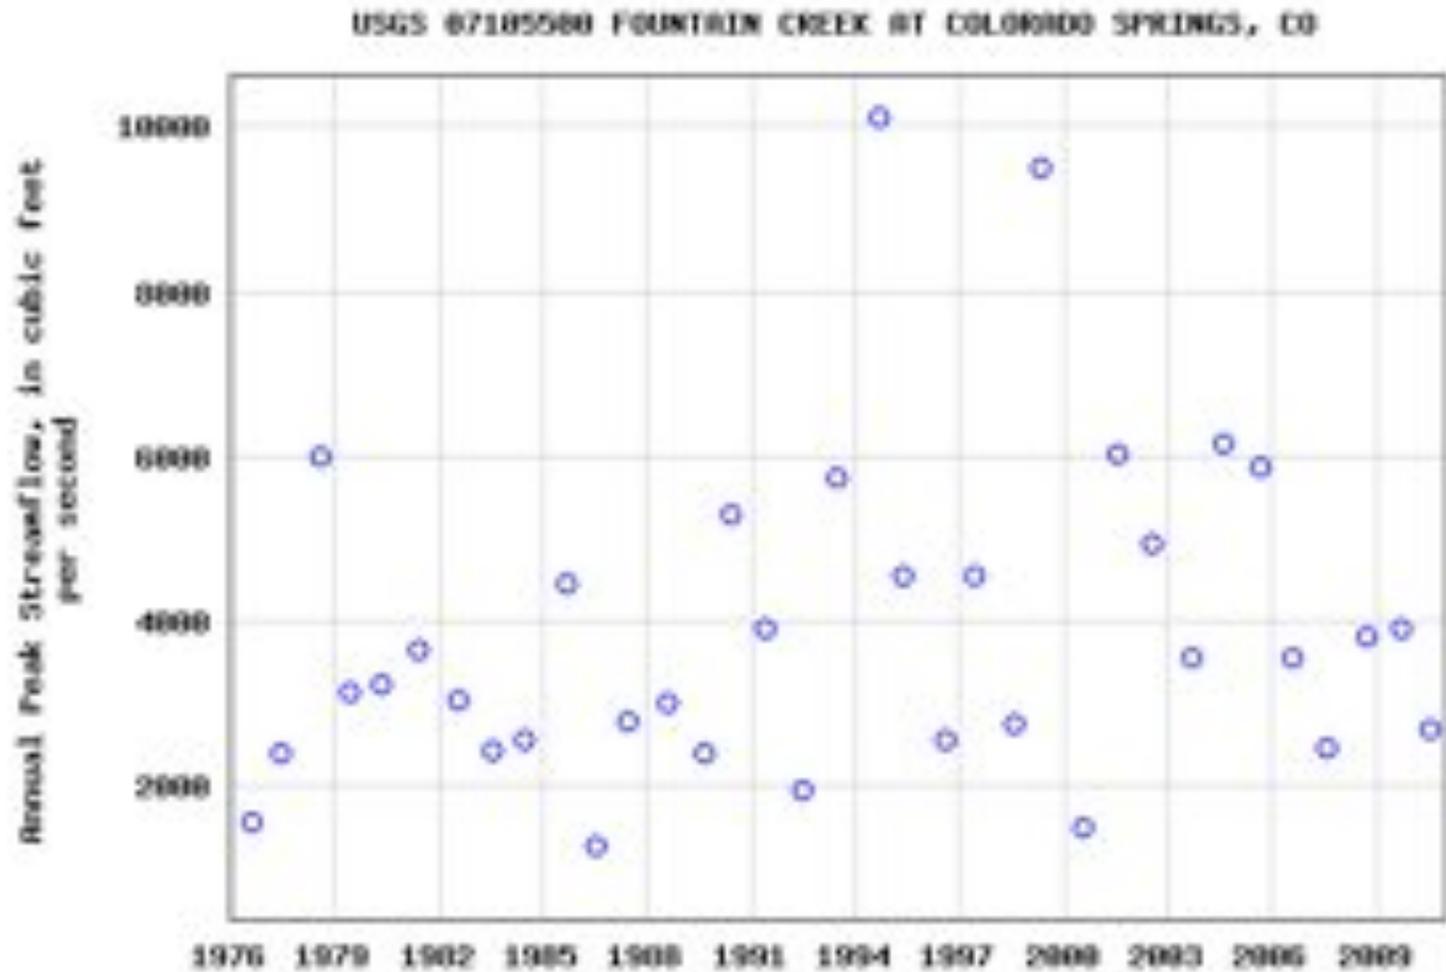
Fountain Creek USGS Gage (5 miles upstream, no significant tributaries)...
Peak magnitudes increasing? Urbanization...???

-Coming into equilibrium with higher discharges...due to urbanization upstream?

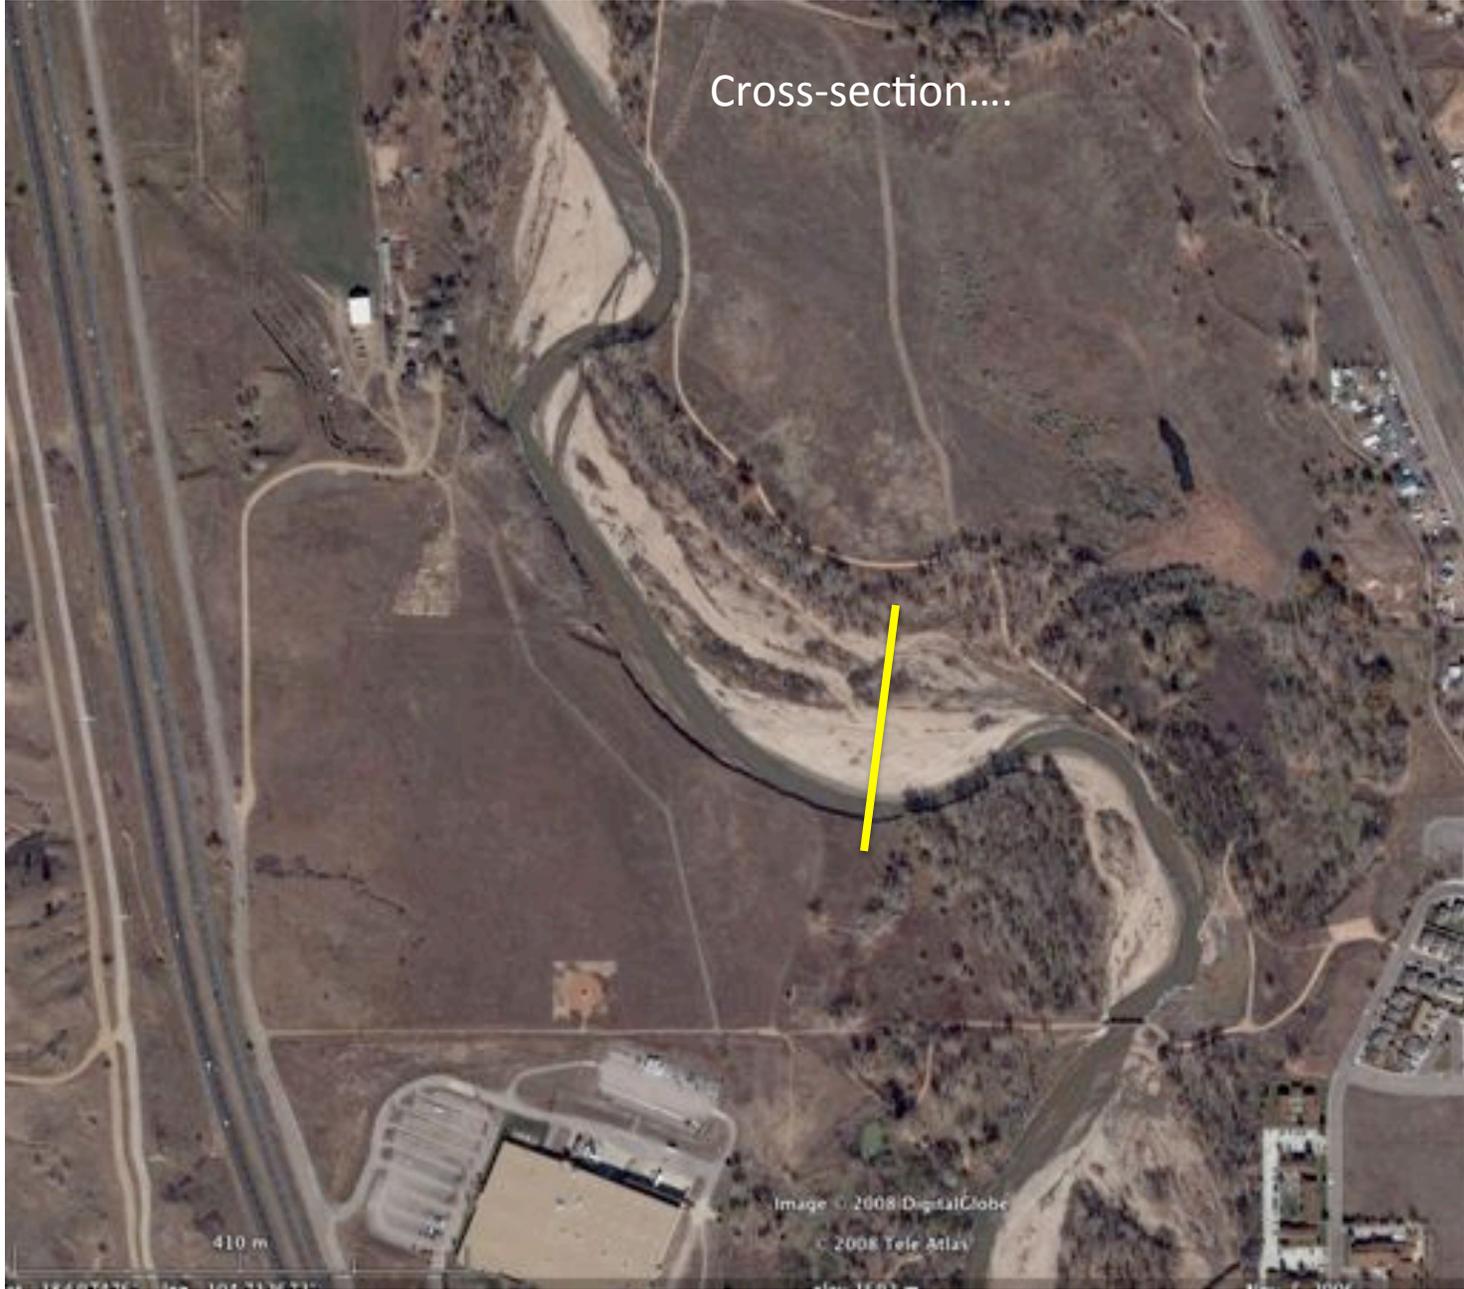
Cross-section...

Example Cross-section...Oct. 2008

410 m
