## Surface Process Hazards Unit 1: Slope failure and society – case studies from Peru and Italy

Sarah Hall, College of the Atlantic  
Becca Walker, Mt. San Antonio College

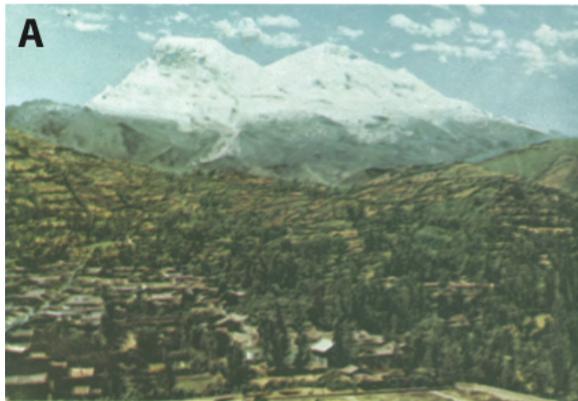
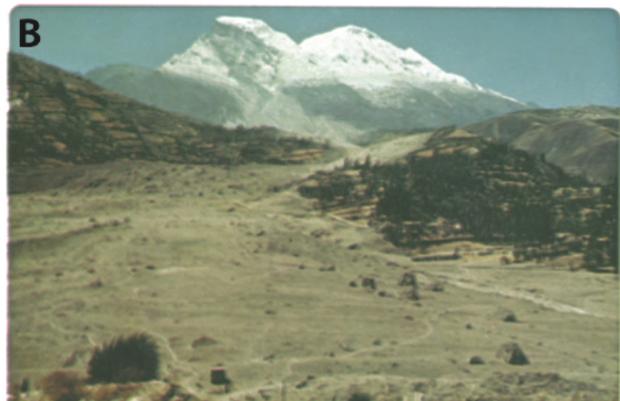
The town of Yungay, Peru and surrounding rural area with Huascarán in the background before (A) and after (B) the May 31, 1970 debris flow. Courtesy of the National Information Service for Earthquake Engineering, University of California, Berkeley. <http://nisee.berkeley.edu/elibrary/Image/S3809>.\*

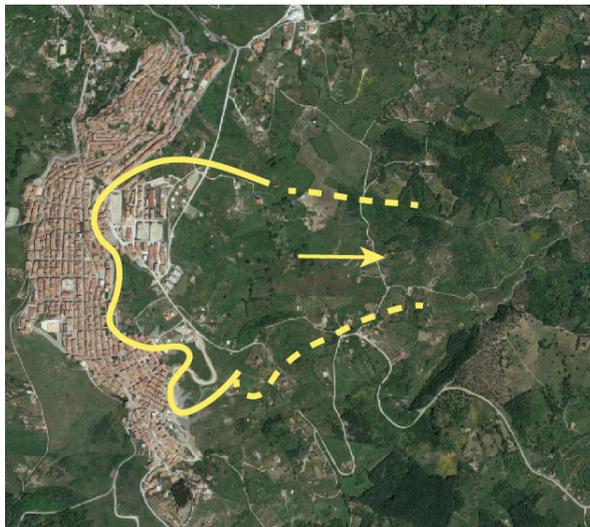
Approximate area of mass movement in San Fratello, Italy in 2010. Base image from Google Earth. Figure after Figure 3 in [http://sgi1.isprambiente.it/geoportalenews/sanfratello/Relazione\\_San\\_Fratello.pdf](http://sgi1.isprambiente.it/geoportalenews/sanfratello/Relazione_San_Fratello.pdf)

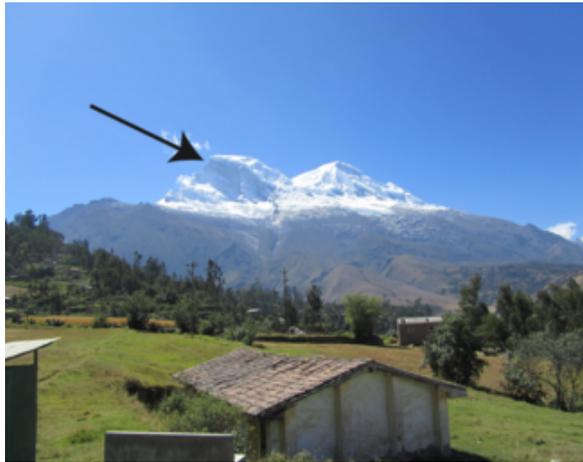
Figure 1. Nevado Huascarán, the highest peak in Peru (elevation 6768 m). The scar of the ice/rock avalanche is evident on the north peak (arrow). Image S. Hall.

Nevado Huascarán is the highest peak in Peru and second highest in all of the Andes Mountains (Figure 1). Rock and ice falls originating from Nevado Huascarán have occurred throughout history and will likely continue to occur with ongoing glacier melt and active seismicity in the area (Figure 2). Coincident with a magnitude 7.9 earthquake on May 31, 1970, a "rock avalanche" (rock and ice fall) from the west face of the north peak (primarily granodiorite with fractures and joints throughout) converted into a high-velocity debris flow (mud and sediments) which buried towns along the Rio Santa valley on its way to the Pacific Ocean, ~150km (~93 miles) away.

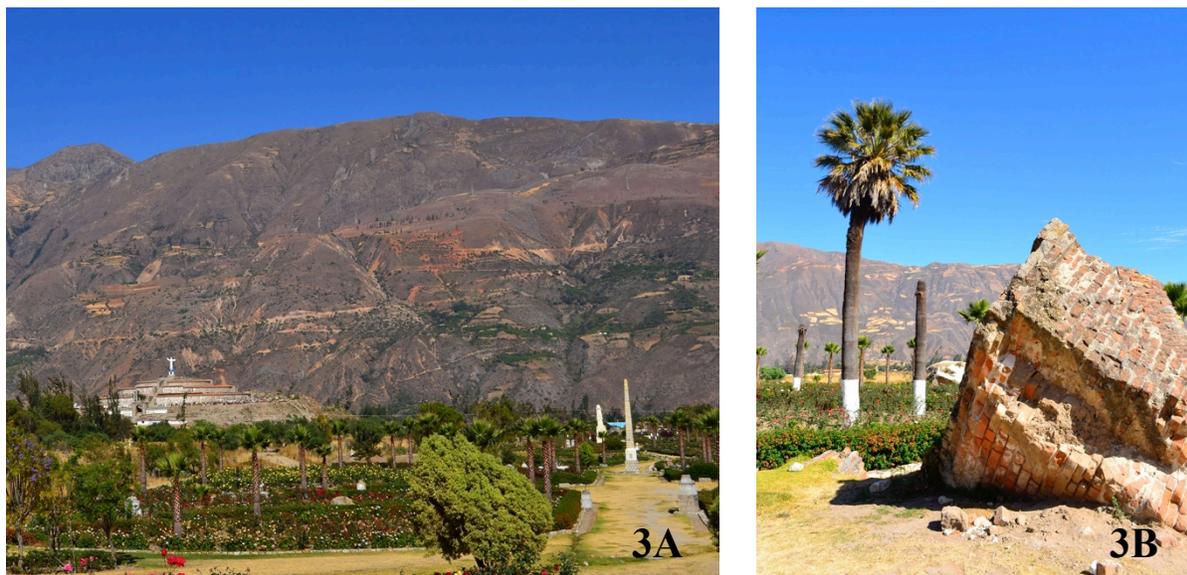
Figure 3. (a) Cemetery Hill (left) and memorial gardens built on top of the buried city of Yungay. (b) Yungay memorial site with partially buried remnants of the old church. Images S. Hall.

In the immediate aftermath of the debris flow, ~4 palm trees stood sticking out of the mud along with pieces of the town church and a regional bus, all of which still remain in the deposit today (Figure 3b). The town of Yungay is now a memorial site where thousands of Peruvian and international visitors come each year. The surrounding area is being resettled and the town of Nueva Yungay has been established nearby, yet away from the paths of the past flows (Figure 6).

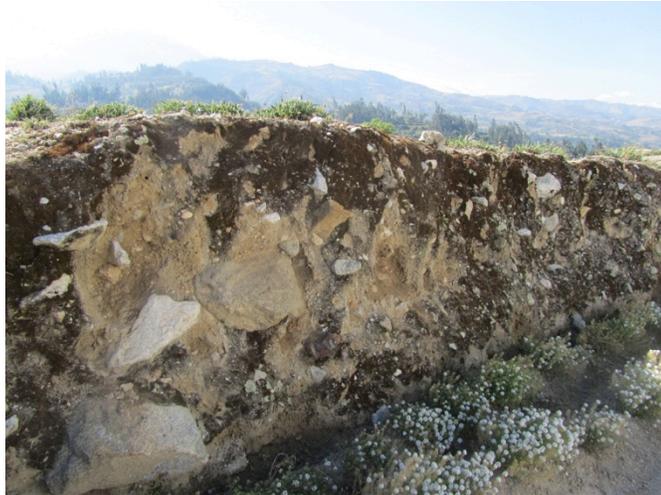
Figure 4 1970 debris flow deposit at the based of Cemetery Hill in Yungay, Peru. Note the large angular clasts in a fine-grained matrix. Image S. Hall.

evidence in these deposits for debris flows similar in style and scale to the 1970 debris flow (Figure 4).

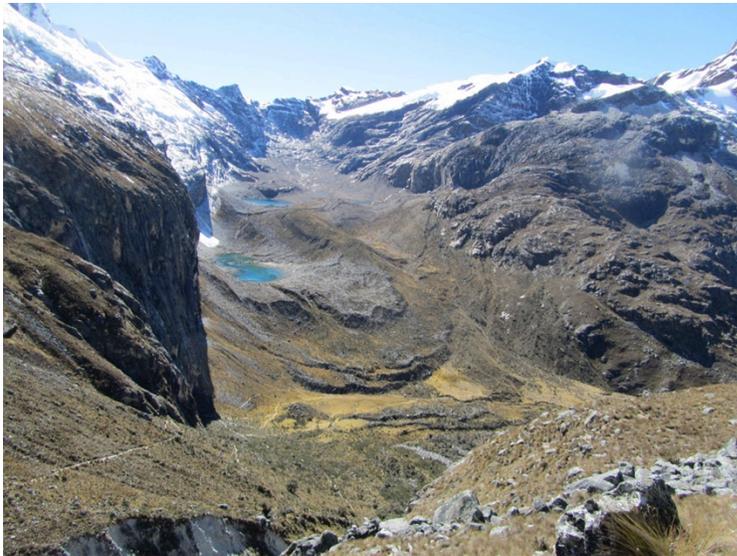
Figure 7. End moraines composed of till (a mix of clay, gravel, cobbles, and boulders) are left behind as glaciers melt and retreat up valley. Moraines such as these block the flow of water through the valley and host lakes that could burst through the moraines in an especially wet year or as result of shaking or ice/rock fall into the lake. Image S. Hall.

Glacial landscapes are often full of loose sediment – moraine material, boulders, colluvium – and have lakes or bogs filling areas upstream of end moraines that cross the U-shaped valleys (Figure 7). If a mass, a block of ice, rock, landslide material, or merely a large amount of water falls into

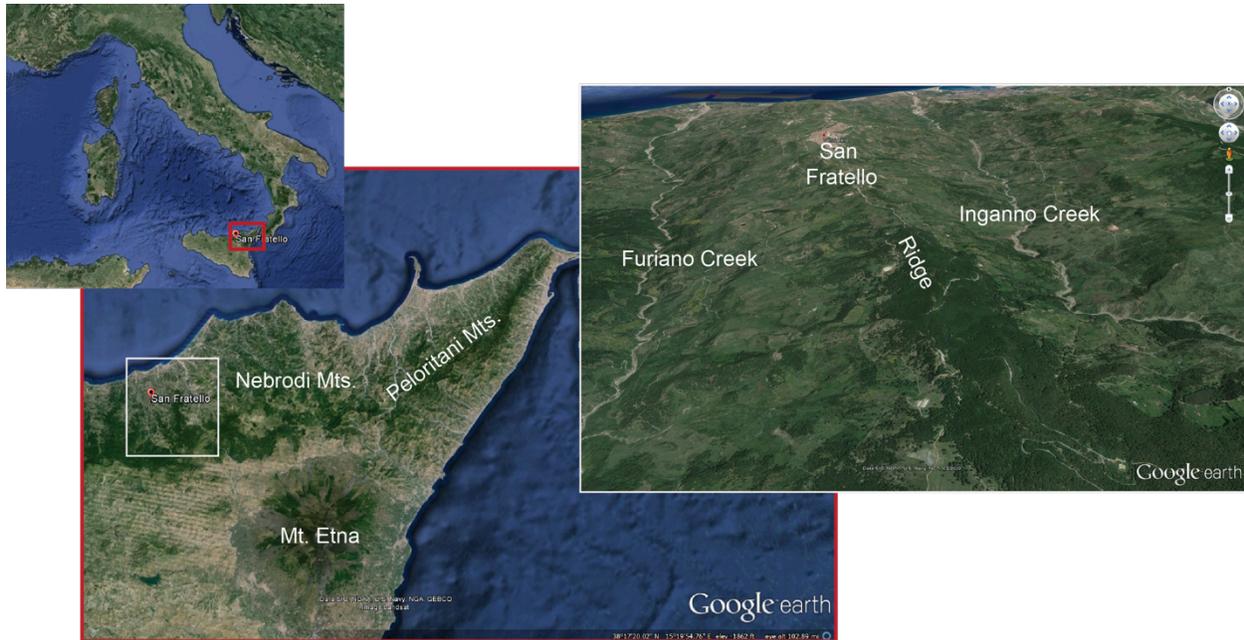
Figure 8. Maps showing the location of San Fratello within Italy (top left), the proximity to the Nebrodi Mountains (center), and the relationship of San Fratello with the rivers and topography of the region (top right). Imagery from Google Earth.

San Fratello is a hillside town of roughly 4500 residents in the Messina Province of NE Sicily (Figure 8). Lying on the northwest side of the Nebrodi Mountains (part of a larger range called the Apennines), San Fratello sits on a steep ridge with 2 river valleys on either side—Furiano Creek and Inganno Creek (Figure 8).

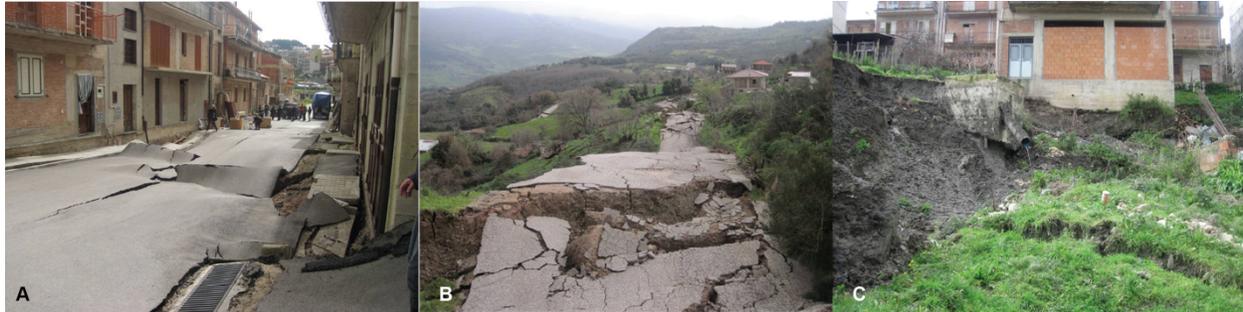
Figure 9. Infrastructure damage as a result of the 2010 landslide. ISPRA. <http://sgi1.isprambiente.it/geoportalenews/Sanfratellodoc.html>

pattern) and extensional and compressive fractures (Figure 12). Observed landslide scarps (steep regions where the slip surface has reached the Earth's surface and caused a ground rupture—see figure 15) 5-10 m (~15-30 ft) high developed about 1/4 mile from the center of town. With the modification of the Earth's surface came rapid changes in surface water flow patterns and led to the creation of several small "landslide lakes"(Figure 13). An earth flow was generated in the lower portion of the landslide area and entered a tributary of Inganno Creek. Infrastructure damage was extensive. Water and sewer pipelines, schools, churches, and homes were damaged and in some cases, completely destroyed (Figure 9).
