Landslide Risk Management

Landslide Hazard in India

LANDSLIDE HAZARD ZONATION

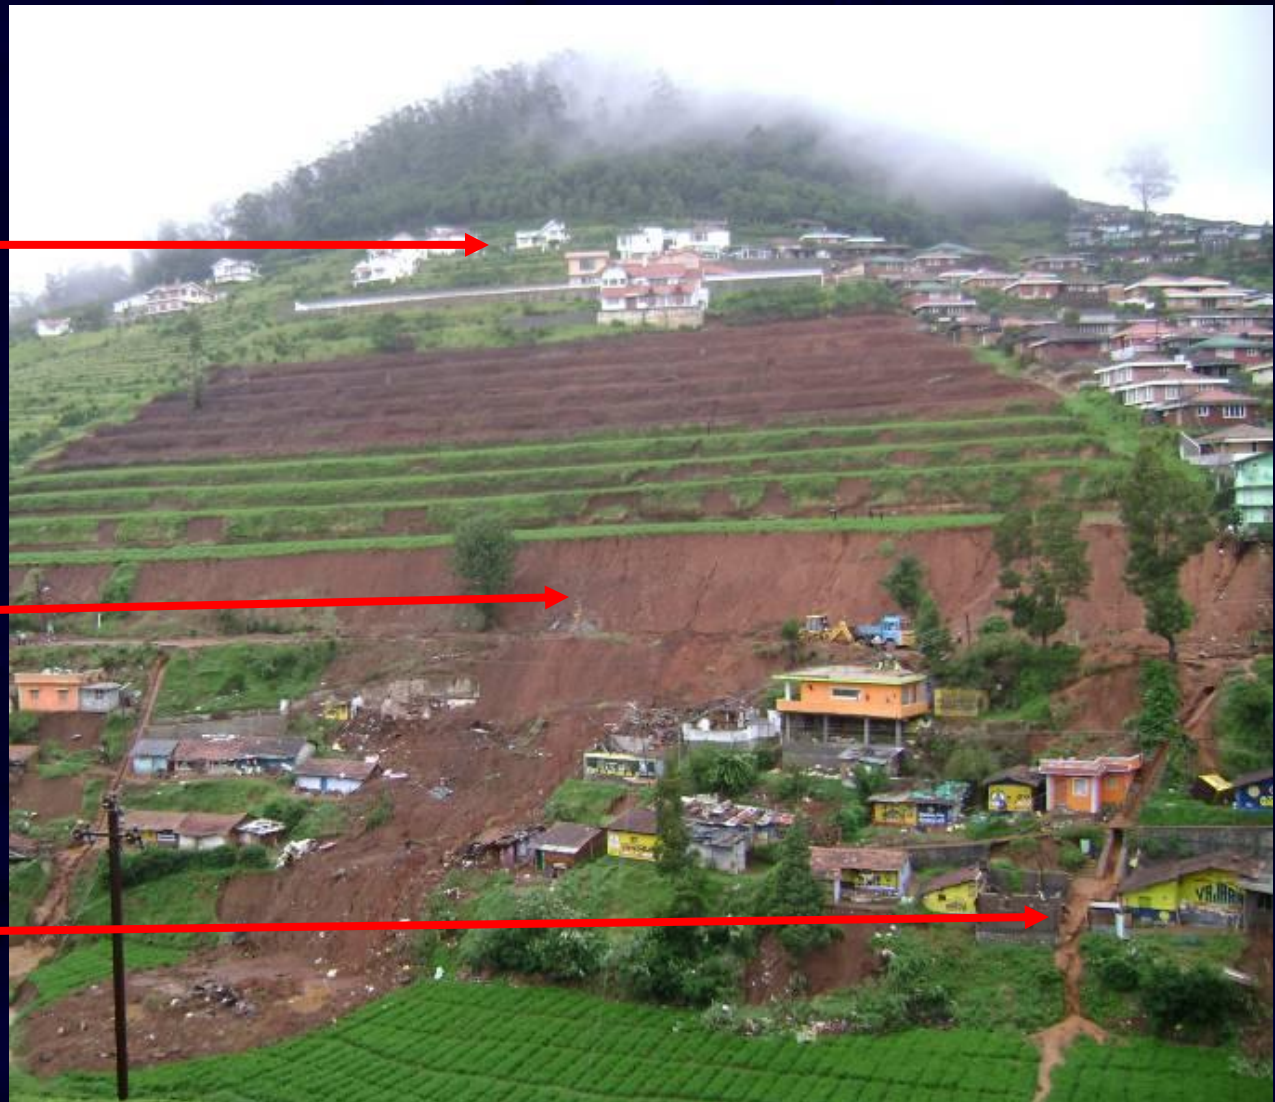
Lovedale Road view from Coonoor Road 10.11.2009

Increase of Head
Load

Toe Removal

Water

Considering all these evidences the following factors appear to have been involved, singly or in combination, in inducing the landslides.

- Water (Heavy rainfall)
- Toe Removal
- Increase of Head Load

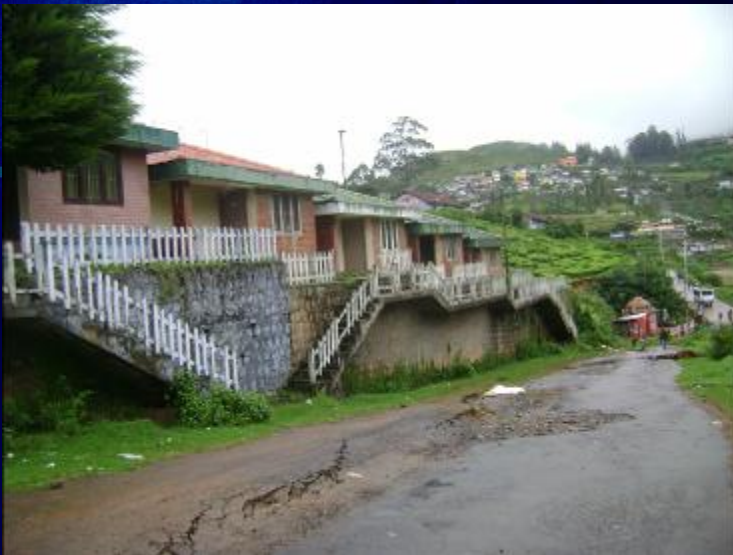
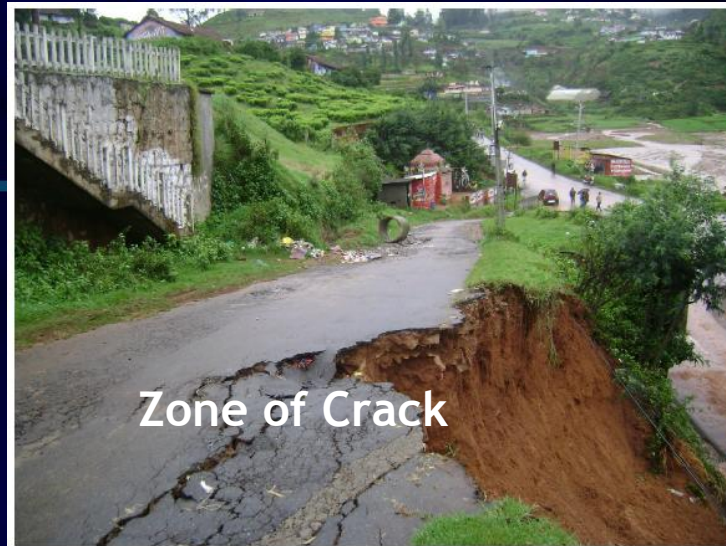
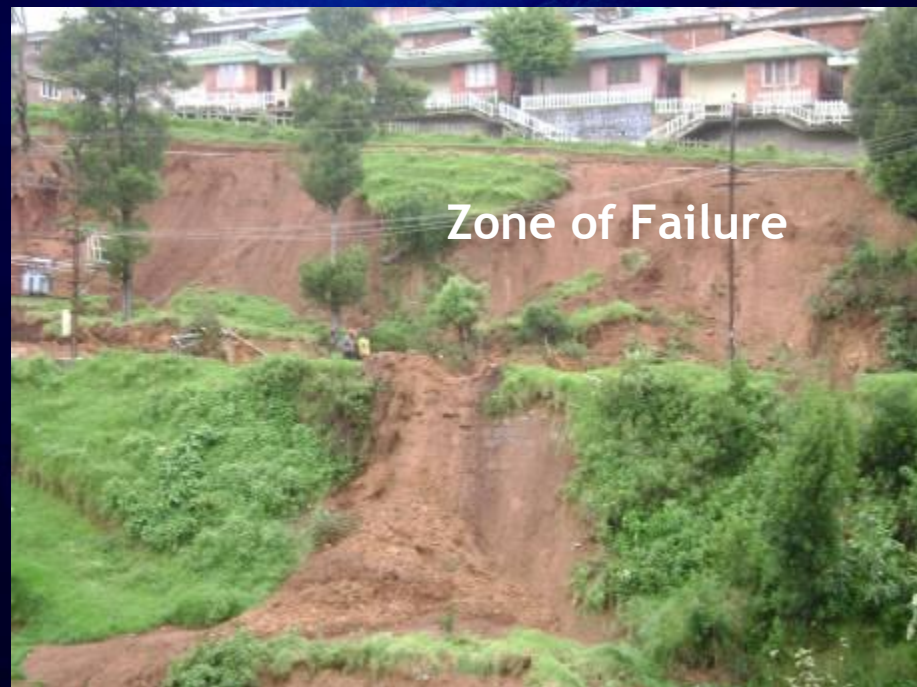
Zone of Crack

Lovedale Road at Thalayattu
Mandu on 10.11.09 top and
bottom side showing the Zone
of Crack and Zone of Failure

Zone of Failure

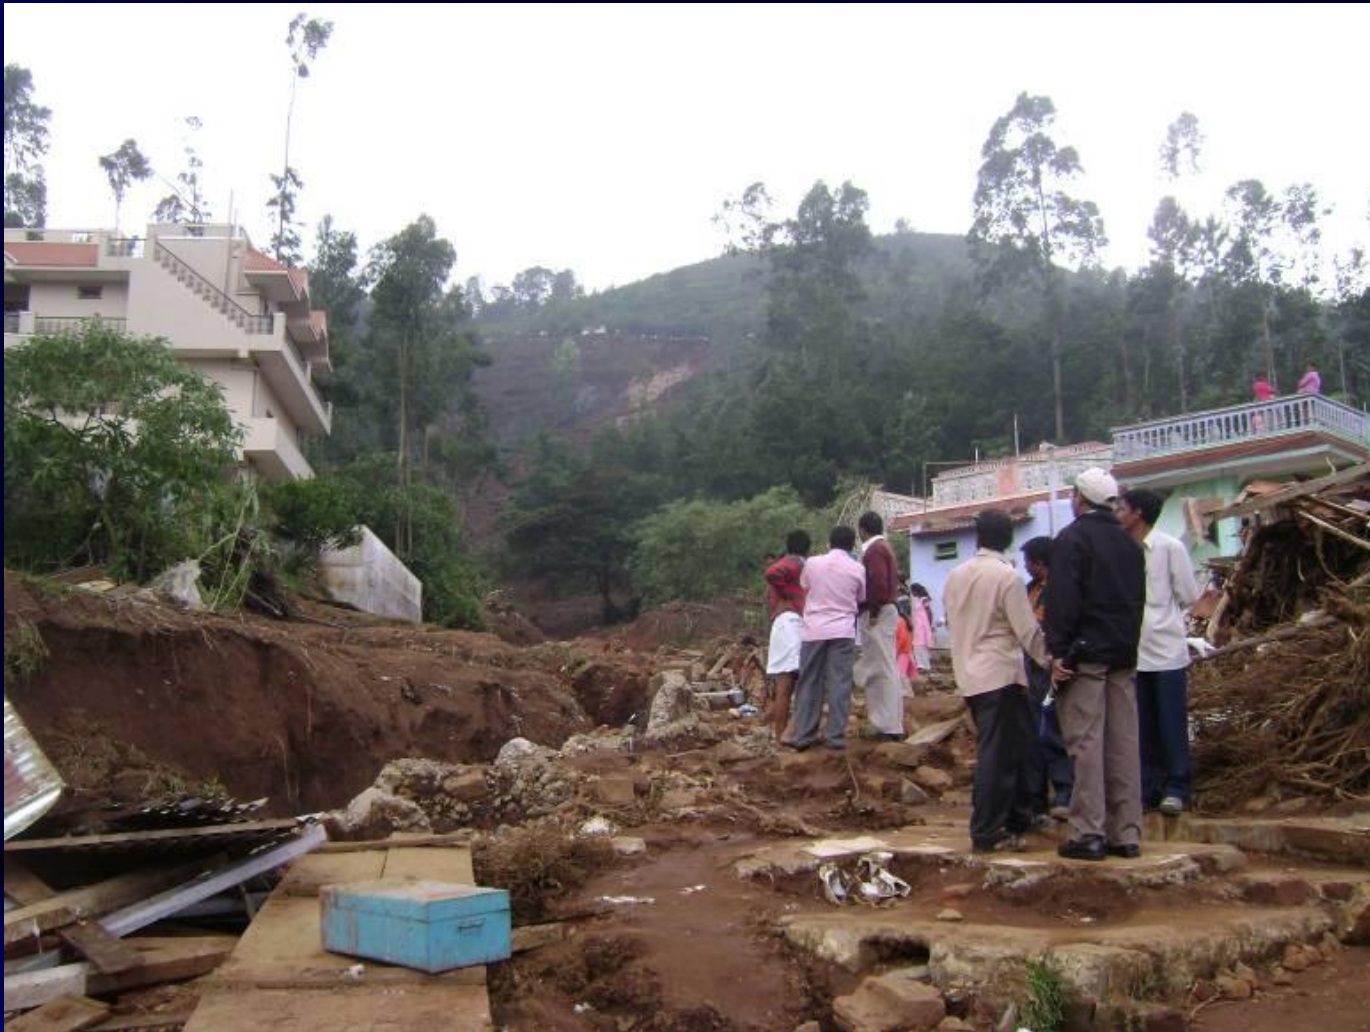
Houses built in the Stream Channel - Severe Damage at Naduhatti

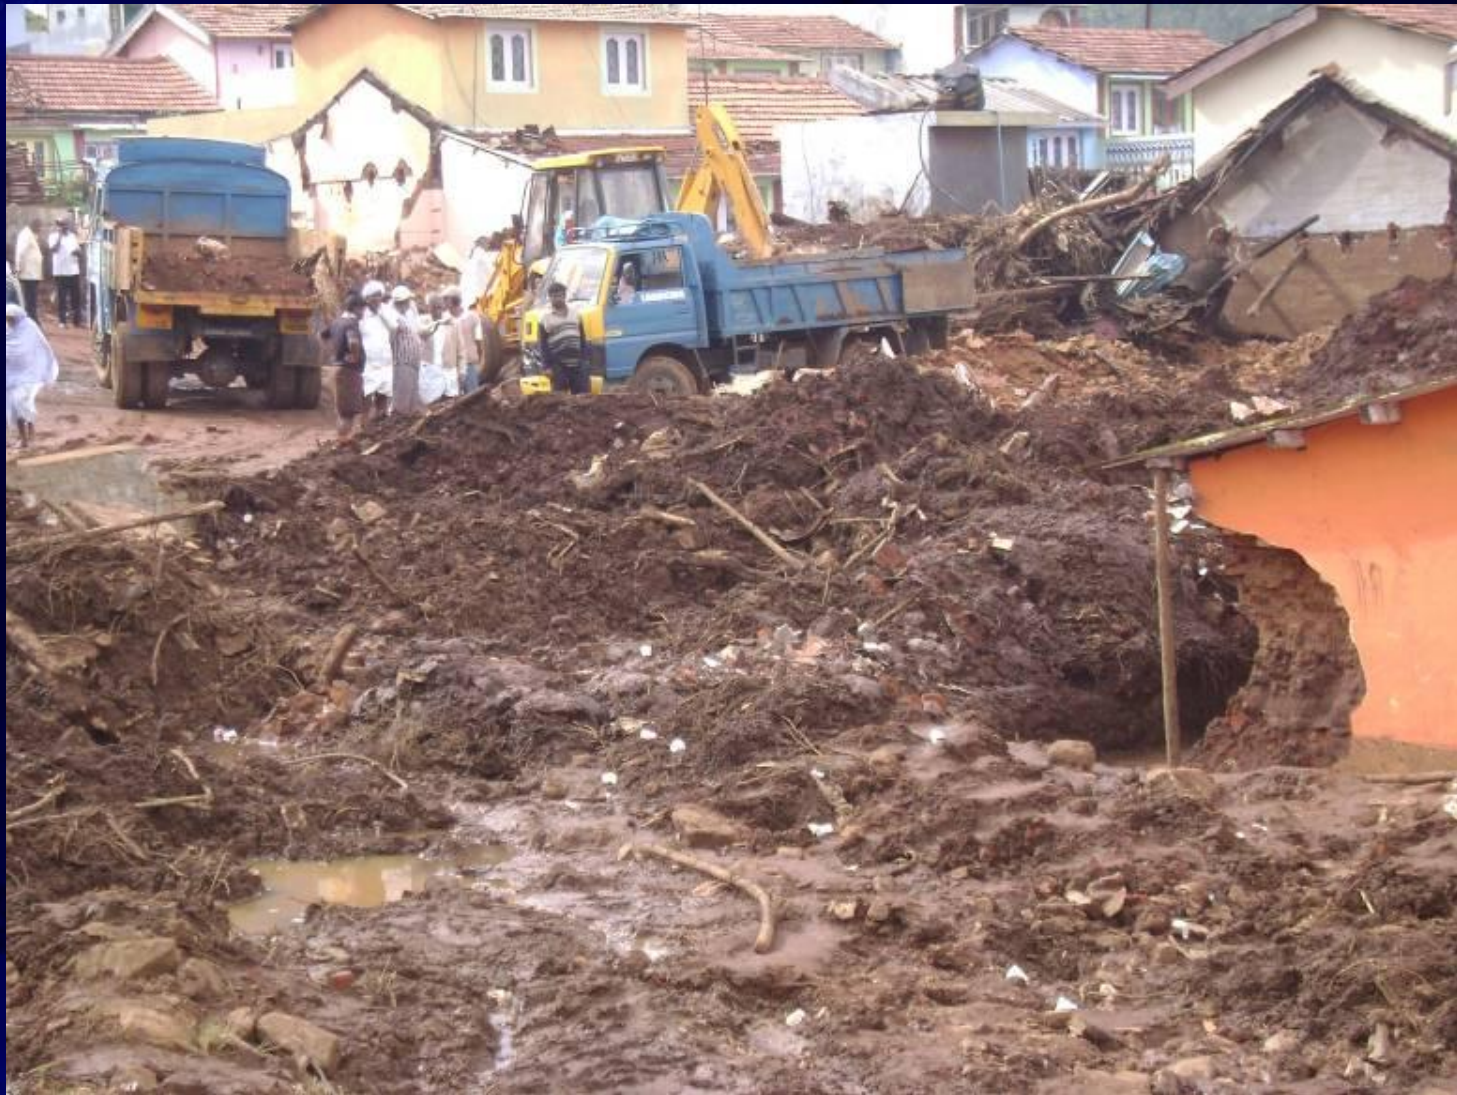
Debris covered at Naduhatti

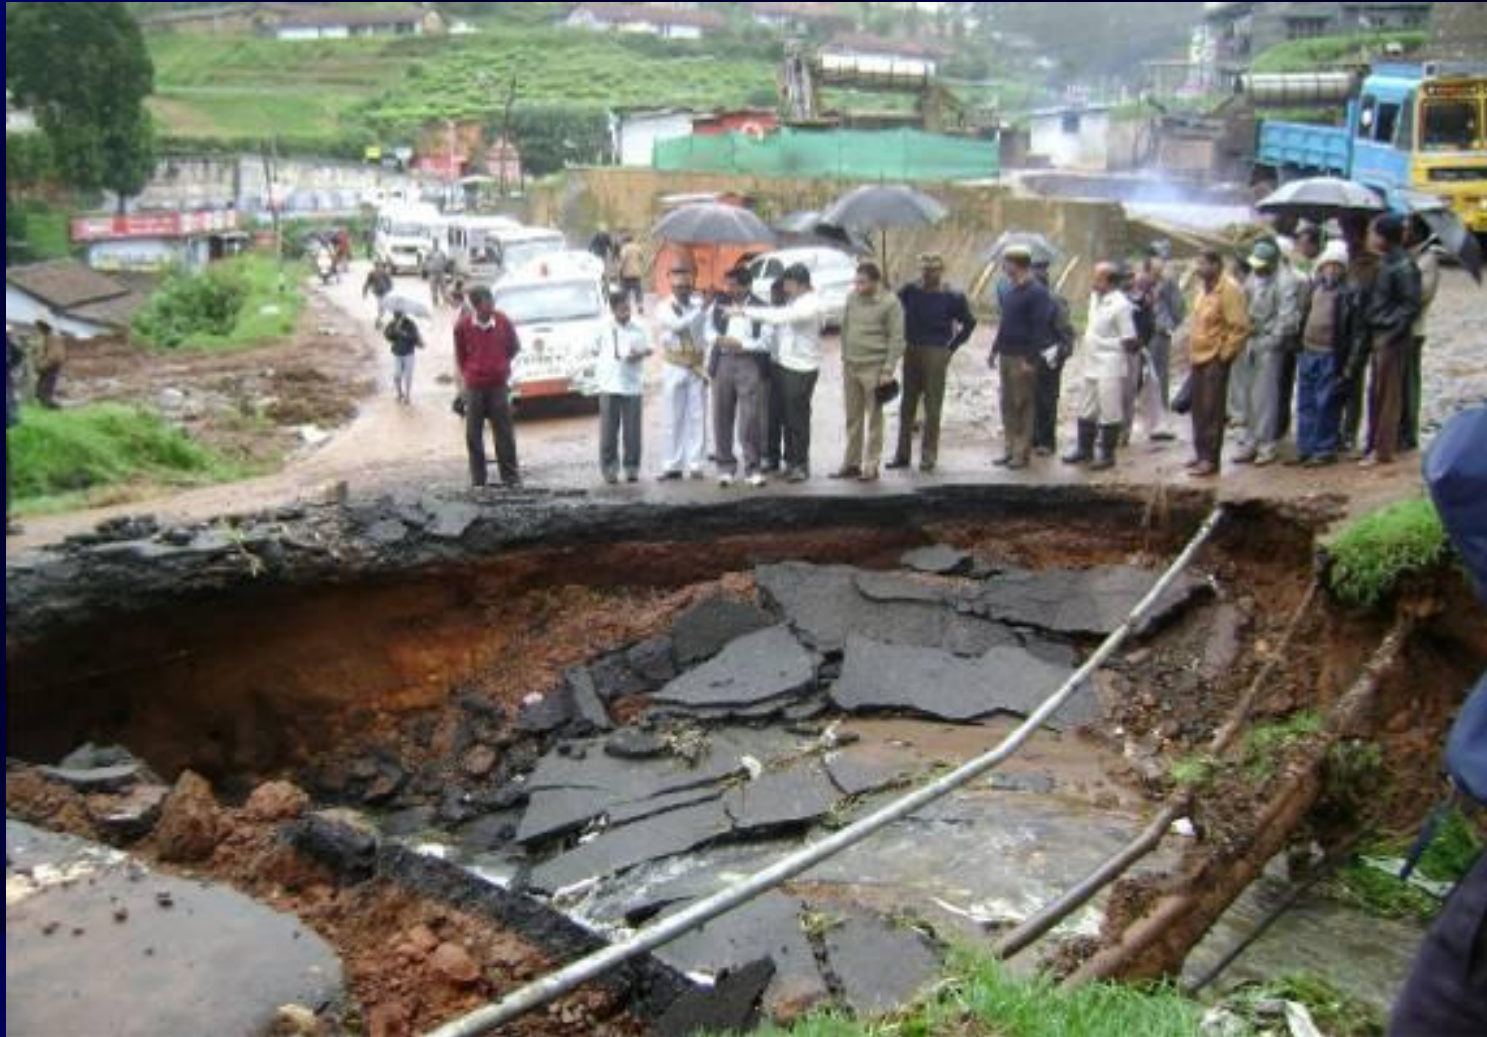
Severely Damaged Road - Ooty Coonoor Road near Thalayattu Mund Junction.
